# Building Survey Report

[REDACTED] September 2025

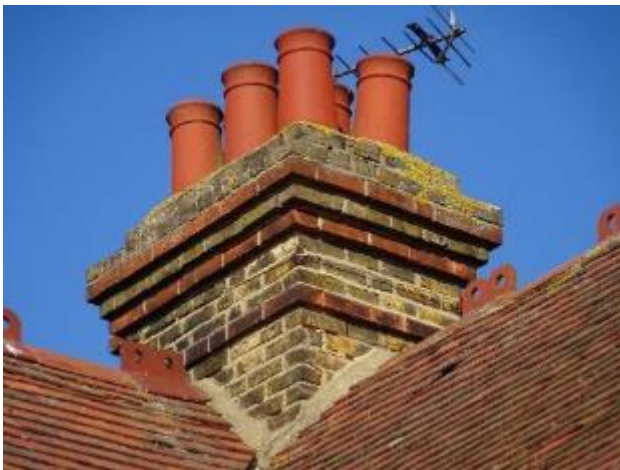
The property has two chimney stacks associated to it, one located to rear left of the property and the other to the centre which is shared with the neighbouring property. The stacks are of solid masonry construction with a brick crown cap. The pointing to the stack was noted to be in good order with some small areas of moss growth was noted to the brickwork, which overtime can cause the pointing to loosen, and it is recommended that these areas are cleaned.

1 - Chimney stack to centre

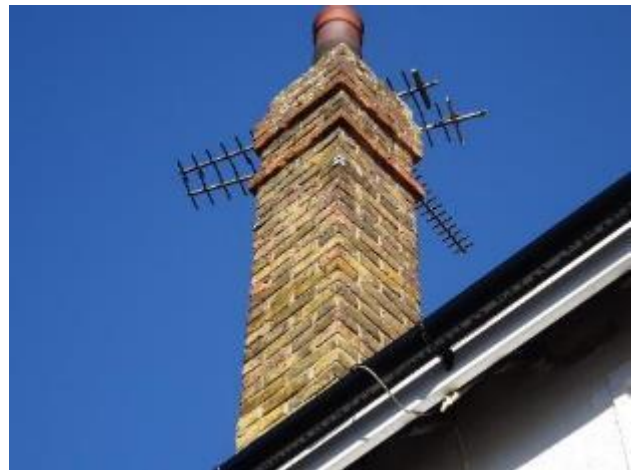
2 - Chimney stack to left elevation

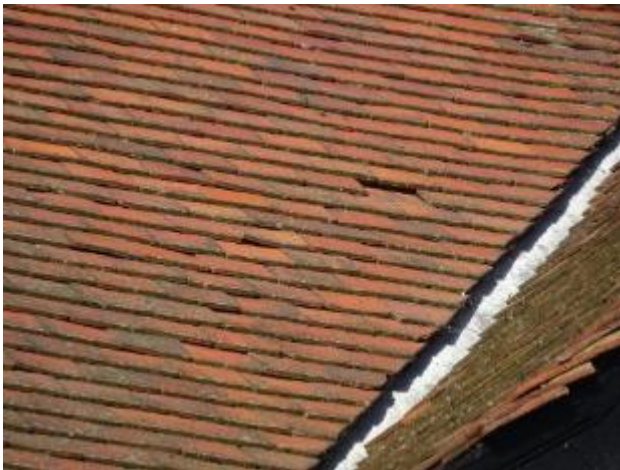
To the elevations moss and lichen growth were noted to the tiles, particularly to the rear along with some damaged, slipped and missing tiles. Over time this can damage and delaminate the tile causing leaks. It is recommended that works to clear the roof tiles is carried out and allow to and undertake bedding repairs to the various ridge tiles identified during those works.

5 – Slipped/ damaged tiles to front

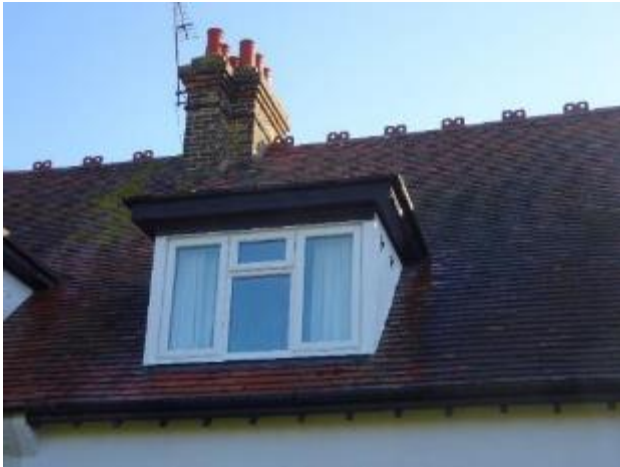
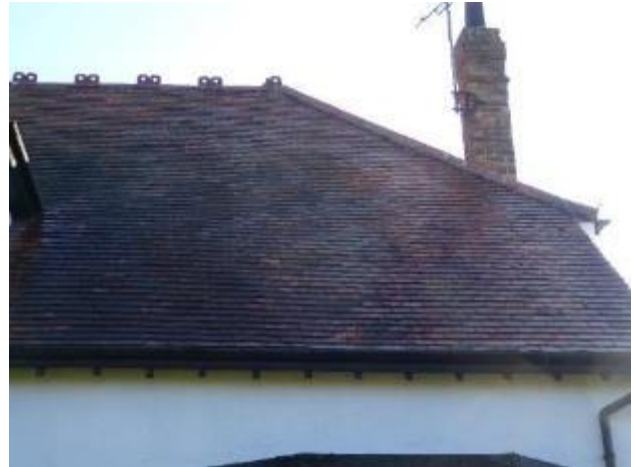
7 - Roof tiles to main roof, rear

8 - Roof tiles to main roof, rear

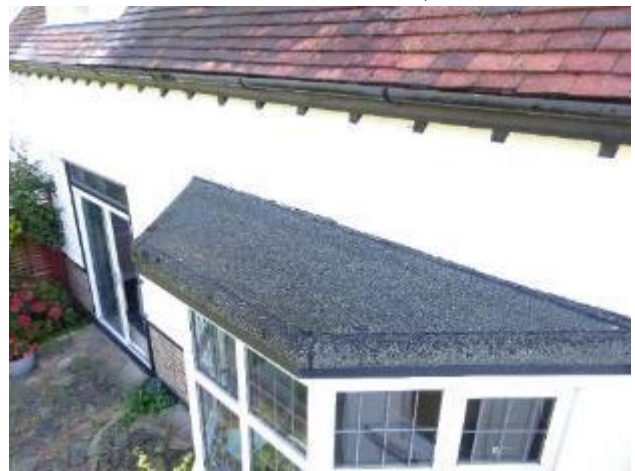
To the rear bay window to the kitchen is a further flat roof which is weathered with a mineral felt covering. This was noted to be in good order, but it would be recommended to clear general moss growth. Mineral felt coverings would typically have an expected lifespan of 35 years with regular maintenance.

10 - Flat roof above rear bay window

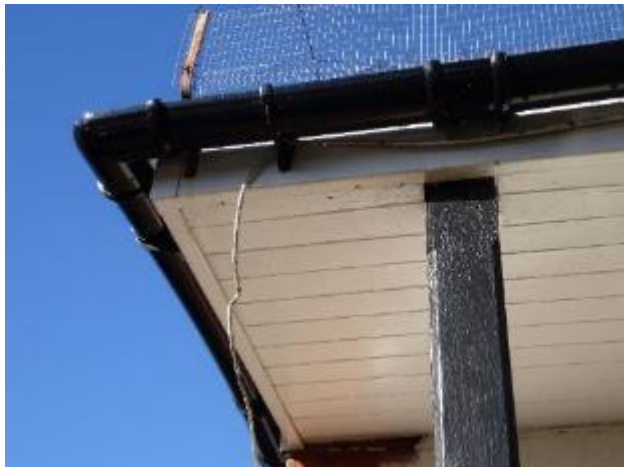
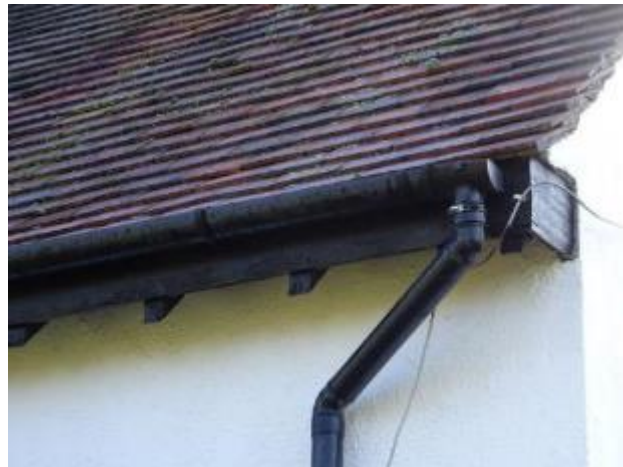
The rainwater goods to the property comprise of uPVC gutters and downpipes to the front, side and rear elevations. These were generally found to be in reasonable order, with vegetation growth blocking the gutters and some localised staining was noted to some of the joints. It is recommended that all gutters are cleared initially and then joints checked and sealed on a cyclical basis.

11 – uPVC rainwater goods

12 – uPVC rainwater goods

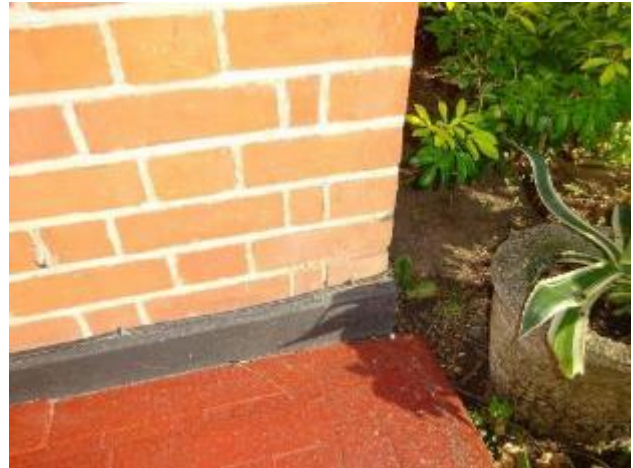
The pointing to the front and rear bay windows were noted to be loose and missing in part. Works to remove further loose sections and repoint these areas would be recommended and carried out within the next 6 to 12 months.

14 – Loose pointing to front bay

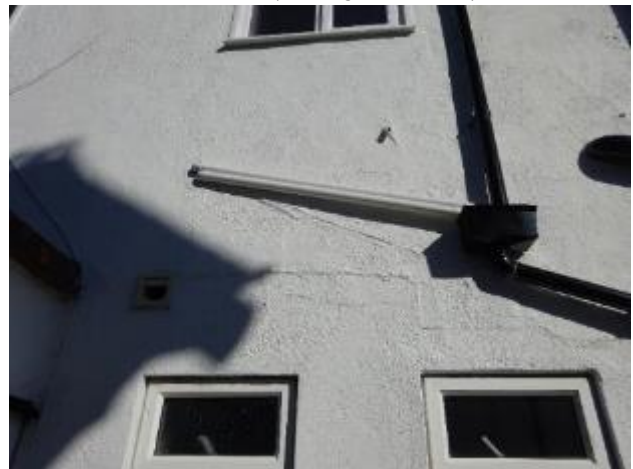
The rendered finish to the property was found to be good order, however, a small number of localised hairline cracking was noted, particularly to the side elevation. It would be recommended that works are carried out to cut out and repair the cracking when undertaking external decorations within the next 12 to 18 months. It is then recommended that the elevations are decorated on a cyclical basis of every 5 to 6 years.

16 – Localised hairline cracking to side elevation

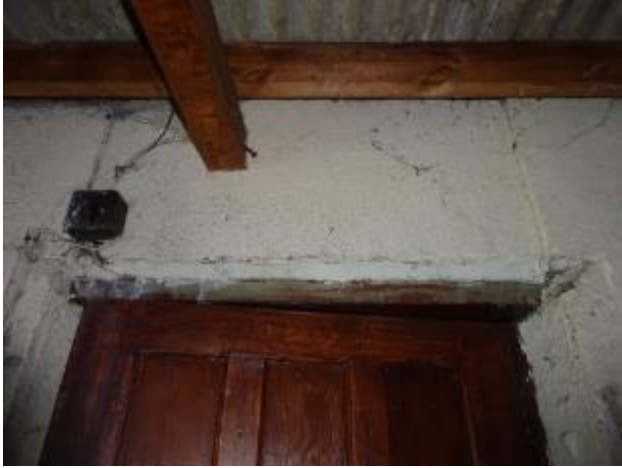
Between the kitchen and lean-to garage is a doorway which has is a later addition to the original construction of the property. The opening has been supported via a timber lintel which was noted to be in poor condition and of a minimum span. This has caused localised settlement cracking above and as such it is recommended that the lintel be replaced and general repairs to the wall and render carried out.

17 - Timber lintel above side door

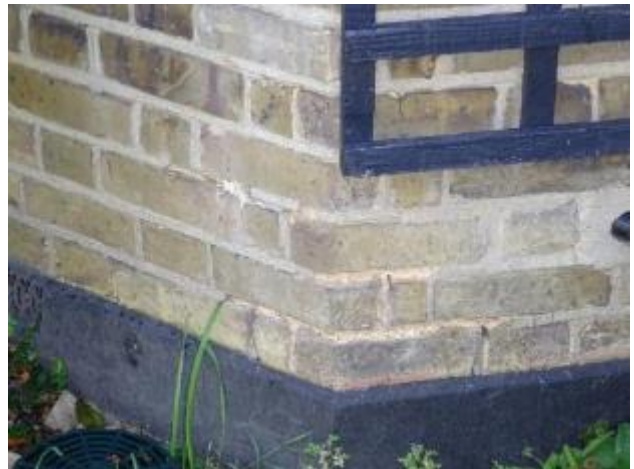
20 - Loose pointing to rear bay

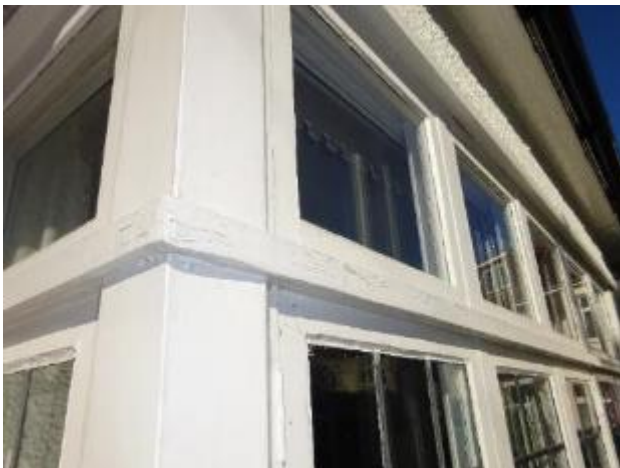
The windows to the ground floor front elevation of the property are of timber construction with single glazed panels with casement and pivot openings to the various frames. The windows were noted to be in reasonable order, and the decorations were found to be flaking and in need of localised repair and decoration, including replacing missing and damaged ironmongery within the next 12 months. It would also be recommended to ease and adjust the individual openings.

23 - Poor decorations to timber windows

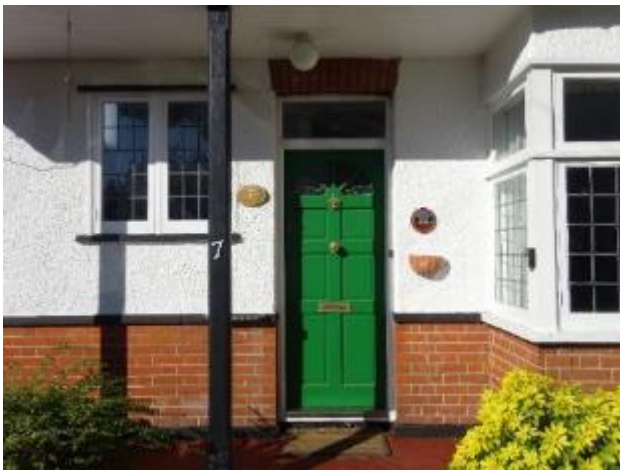
A number of panels within the uPVC frames were noted to have condensation. This would indicate that the seals have failed and as such it is recommended that the damaged panes are replaced. It would also be recommended to prepare and decorate the main entrance door within the next 12 months.

26 - Main entrance door

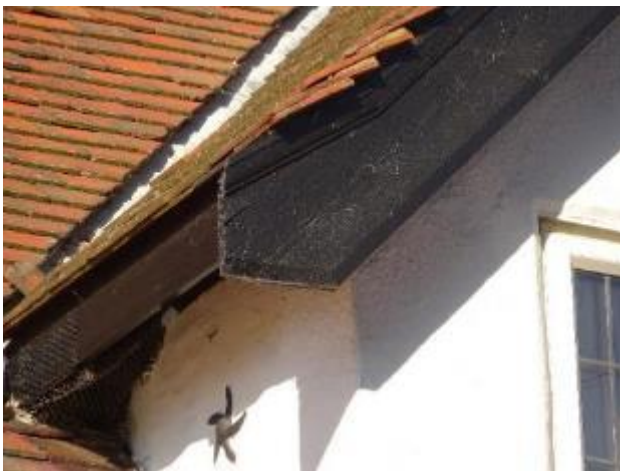
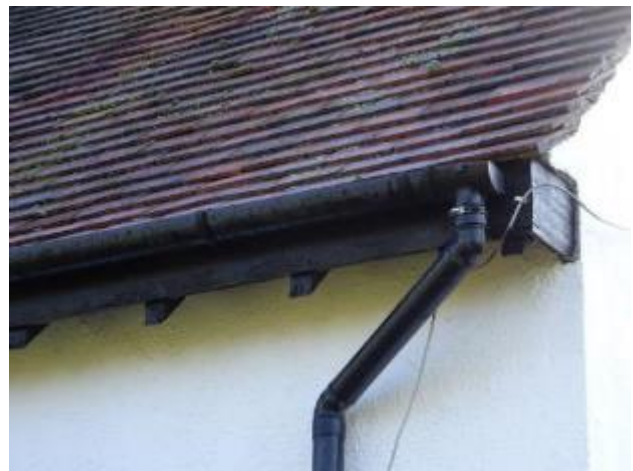
Other sections of the existing soffits and fascia boards are of timber and were found to be in reasonable order, however, it would appear that these have not been decorated for a number of years. These will require general rub down and preparations prior to decoration and it would be recommended that this is undertaken within the next 12 to 18 months to prevent potential damage to the timber then on cyclical basis every 5 to 6 years.

28 – Timber soffit and fascia board

29 – Timber soffit and fascia board

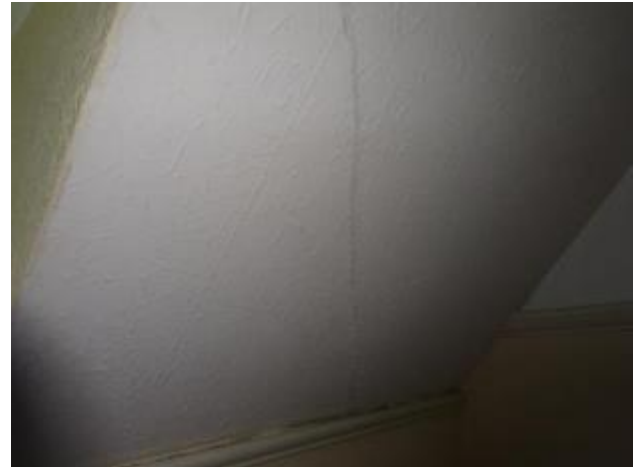
The majority of plasterboard lining within the roof void were found to have thermal cracking and it is likely that large areas would need to be removed and replaced when undertaking general internal decorations.

33 - Thermal cracking to plaster

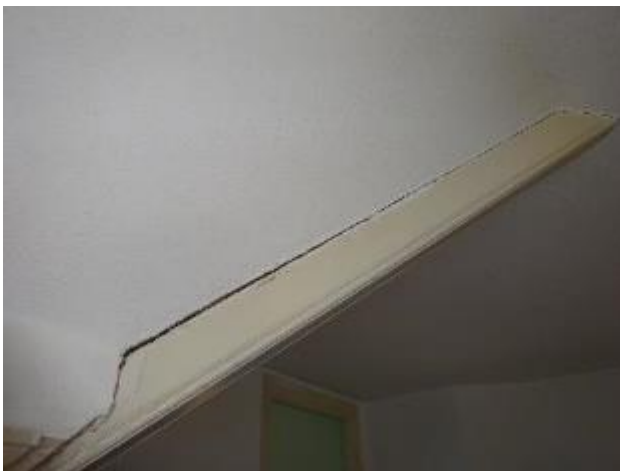
34 - Thermal movement adjacent to front valley

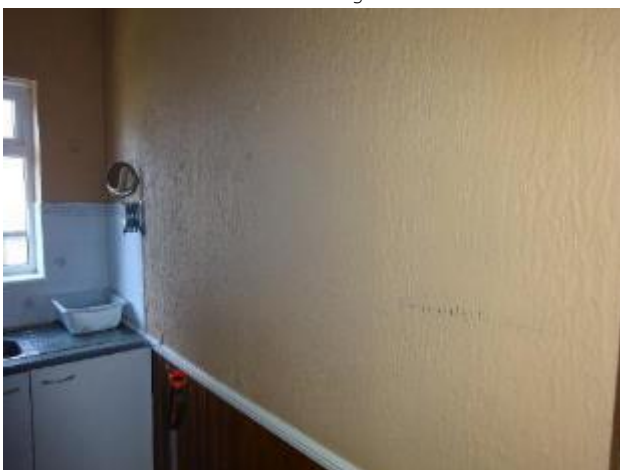
To the walls that have been covered with an Artex finish, such as the kitchen, utility and ground floor shower room, can contain low levels of asbestos, and it is recommended that these areas are tested prior to any removal or major works undertaken to the walls.

42 – Artex covering to utility room wall

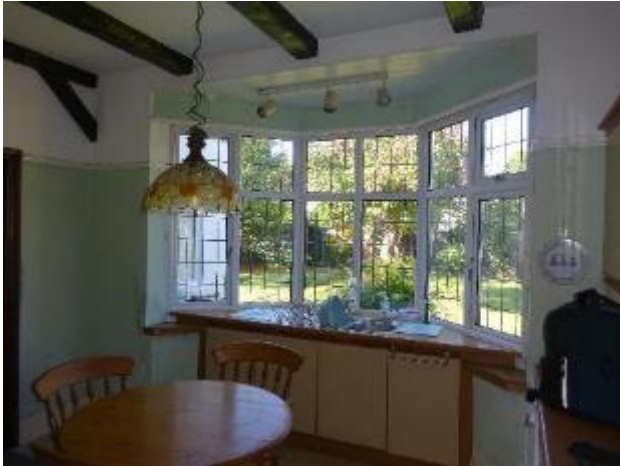
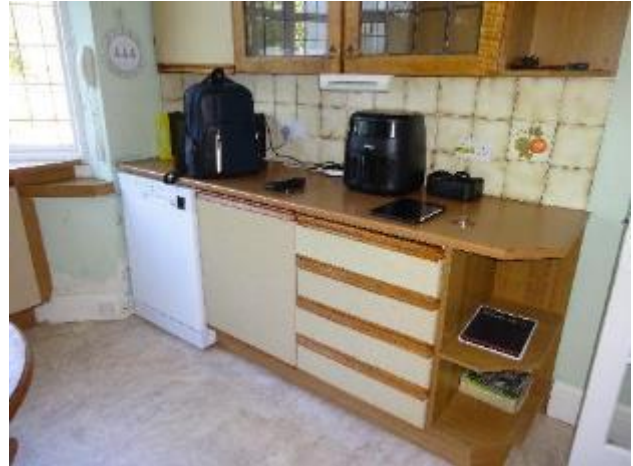
The subject property comprises of a kitchen, utility room and shower room to the ground floor, and bathroom on the first floor. Both the kitchen and bathroom are dated, and it is recommended that both are replaced within the next few years.

50 - Kitchen

51 - Kitchen

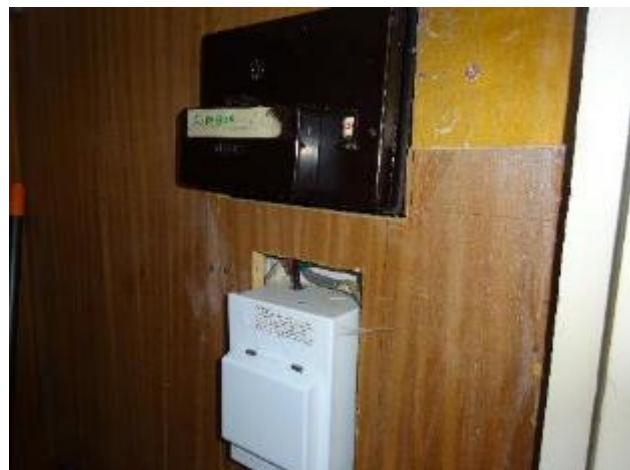
The fuse board is dated along with the wiring, and I would recommend that the property is fully rewired throughout.

57 – Electrical fuse board

Whilst I cannot fully confirm the serviceability and condition of the current electrical installation and considering the age of the ring and lighting installations, I would still recommend an independent full electrical test by an approved contractor to confirm its serviceability and working order in the interim.

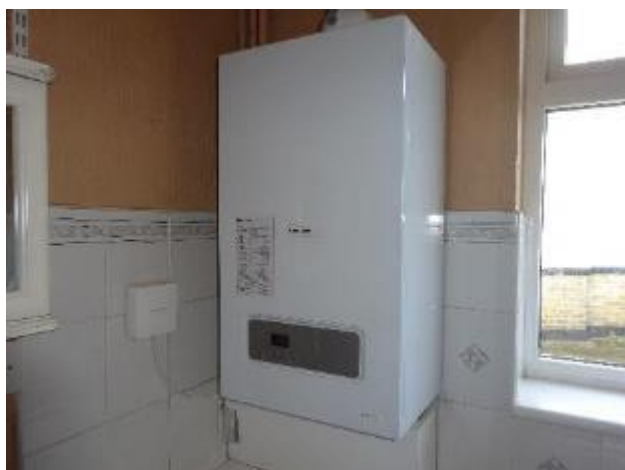
Given the general condition of the existing heating system and the requirement for full refurbishment throughout the property it would be recommended to consider upgrading and changing the heating system and boiler.

59 – Gas fired boiler

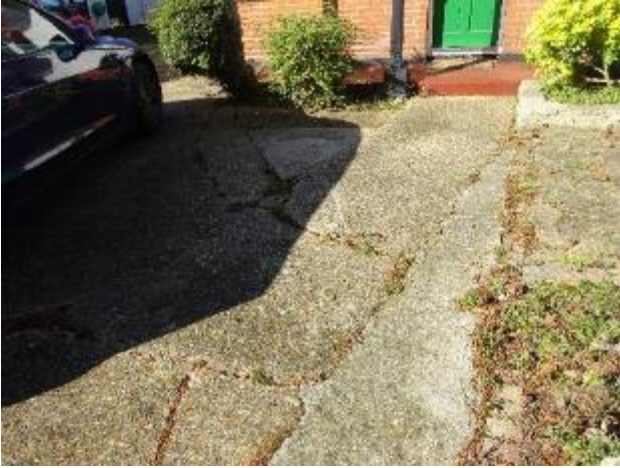
The property has access from the front via the main driveway which comprises of hardstanding concrete providing access to the front entrance. The driveway was found to be in poor order and heavily cracked due to the proximity of the tree to the front of the house. The masonry wall to the front boundary was also note be damaged from ground settlement. It would be expected that the hardstanding and paving slabs would need to be removed and new finish installed with revised sub-base.

62 – Heavy cracked hardstanding concrete

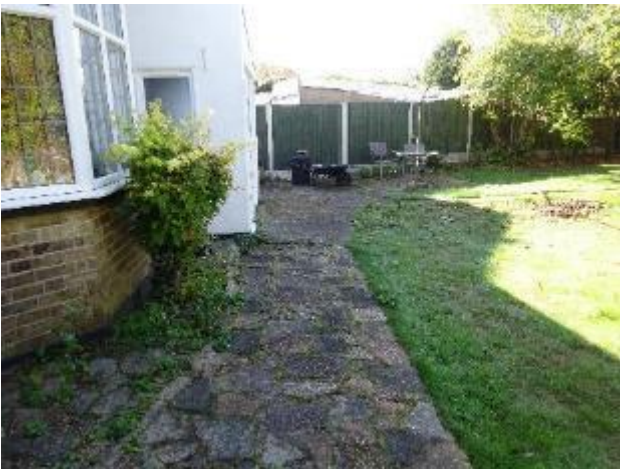
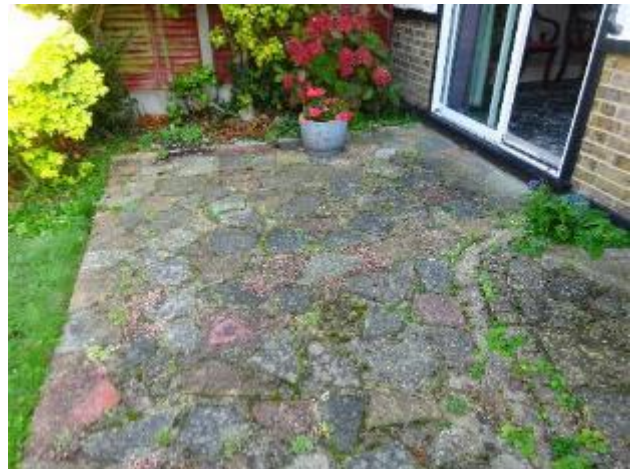
The property has grounds to the rear with access from the lounge and side access gate. The garden is mainly laid to lawn with an area of concrete slabs forming a patio which was noted to have some cracking and unevenness.

64 – Paving to rear

65 – Paving to rear

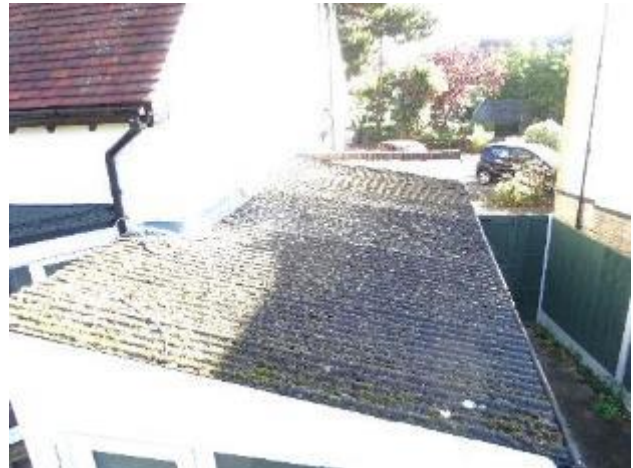
The lean-to roof comprises of profiled asbestos panels which were noted to have heavy moss growth. It would be recommended to strip, remove and replace the roof with a new system. The existing panels would need to be removed and safely disposed of via a specialist contractor.

68 - Asbestos profiled roof

It was noted that it is likely that the profiled roof panels to the garage roof may contain asbestos and should be tested and if required, removed by a specialist contractor.

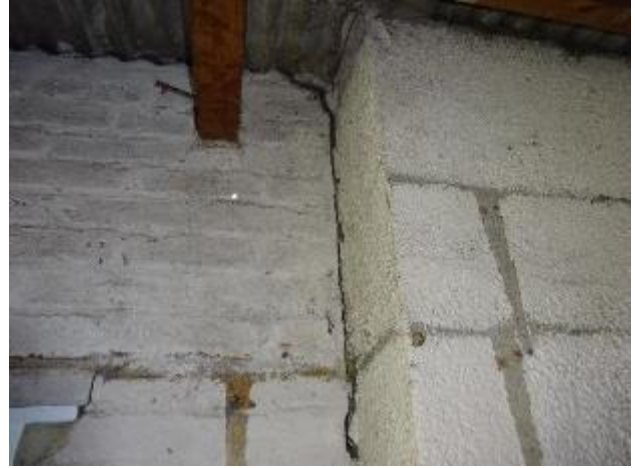
To the side of the property is a lean-to structure forming a garage. The external walls are of single skin brickwork. Settlement movement was noted to the rear junction between the rear wall of the house and garage. Works would be required to tie the walls together in order to prevent further movement.

72 - Settlement/ movement cracking
