Homebuyers Survey Report

August 2025

The subject property comprises of semi-detached residential dwelling which briefly comprises of a lounge, kitchen and reception to the ground floor, with three bedrooms and bathroom to the first floor.

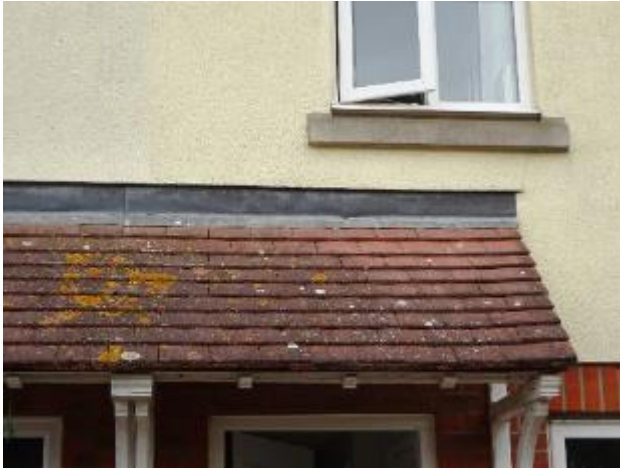
To the front of the property is a lean-to canopy roof above the main entrance. This is finished with square edged concrete tiles which were noted to have some localised moss and lichen growth which would benefit from being cleaned in conjunction with the main roof.

1 - Canopy roof to front

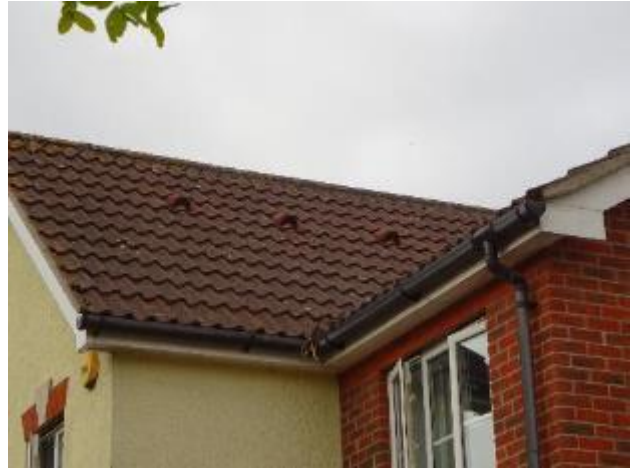
To the elevations moss and lichen growth were noted to the tiles, particularly to the ridge tiles. Over time this can damage and delaminate the tile causing leaks. It is recommended that works to clear the roof tiles is carried out and allow to and undertake bedding repairs to the various ridge tiles identified during those works.

2 - Roof tiles to front elevation

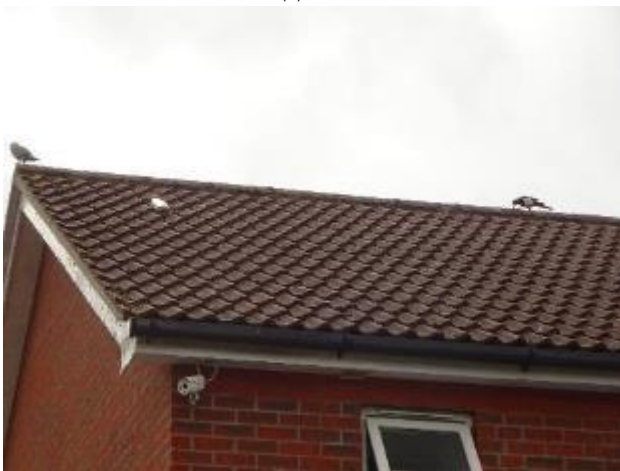
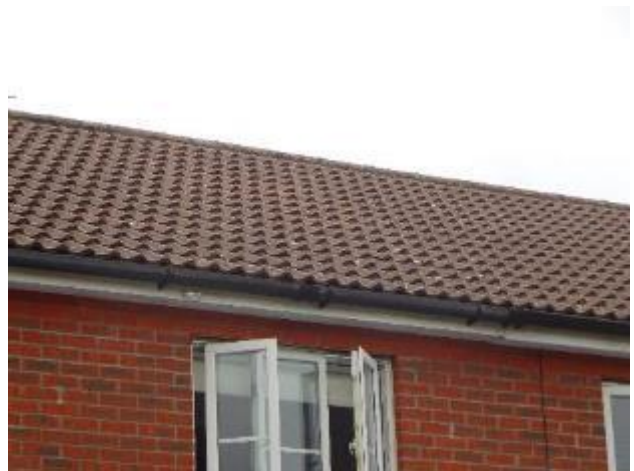
3 - Roof tiles to rear elevation

4 - Roof tiles to rear elevation

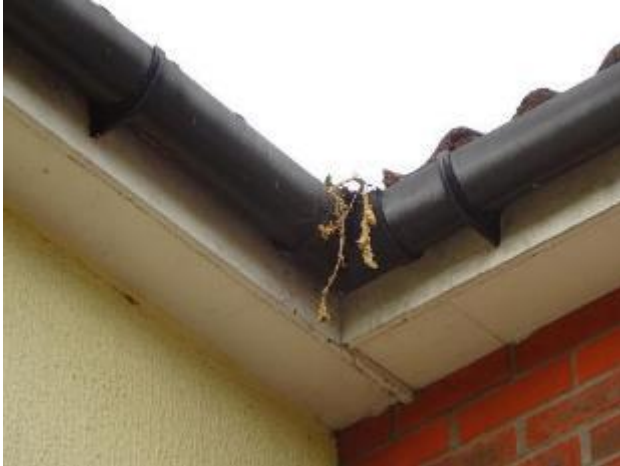
The rainwater goods to the property comprise of uPVC gutters and downpipes to the front and rear elevations. These were generally found to be in good order, some localised vegetation and staining was noted to some of the joints. It is recommended that all gutters are cleared initially and then joints checked and sealed on a cyclical basis.

5 - Vegetation growth within gutter to front

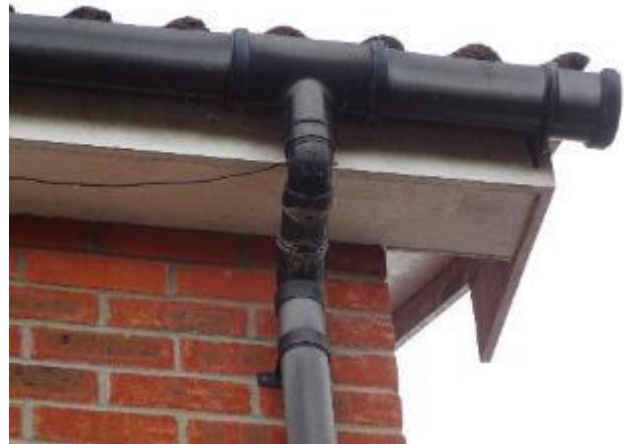
6 - uPVC rainwater goods

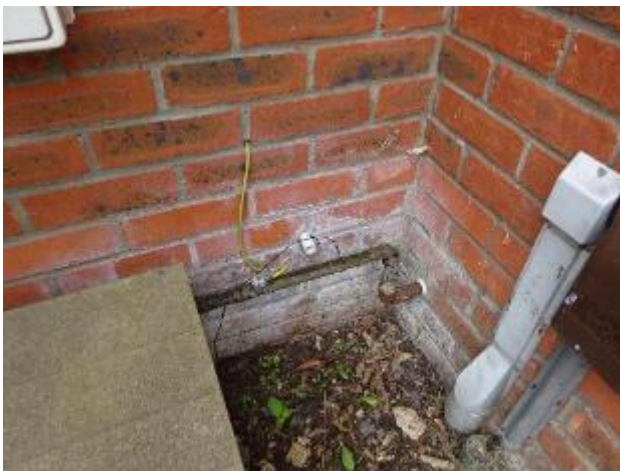
The overflow pipe from the ground floor WC was noted to have stained the brickwork and it would be recommended that this is cleaned. It would be advisable to extend the length of the overflow pipe to prevent staining in the future.

9 - Staining to brickwork

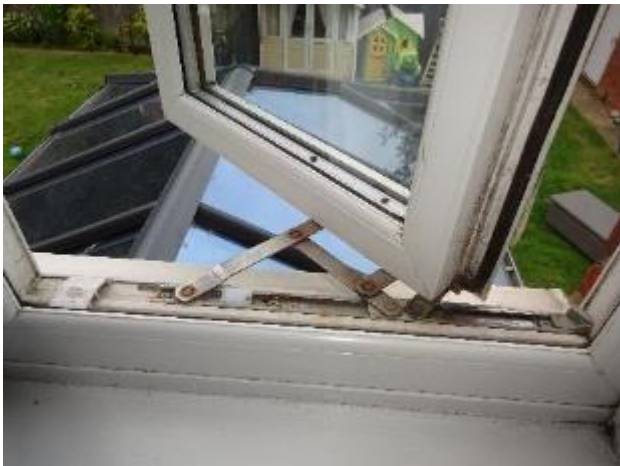
The windows throughout the property are of uPVC construction with uPVC frames and mechanism openings to the various casements. The windows were noted to be in good order, with some debris build-up within the frame making the windows slightly stiff to open. These will require a deep clean with some ease and adjustment in order for them to operate fully.

13 – uPVC window mechanism

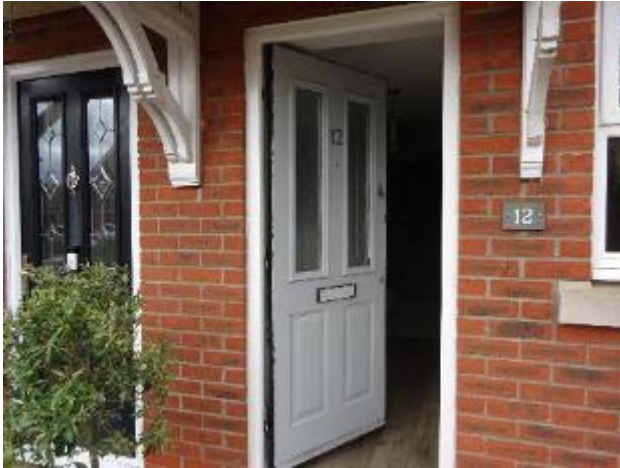
14 – Main entrance door set

The timber door to the front would benefit from general decorations within the next 12 to 18 months.

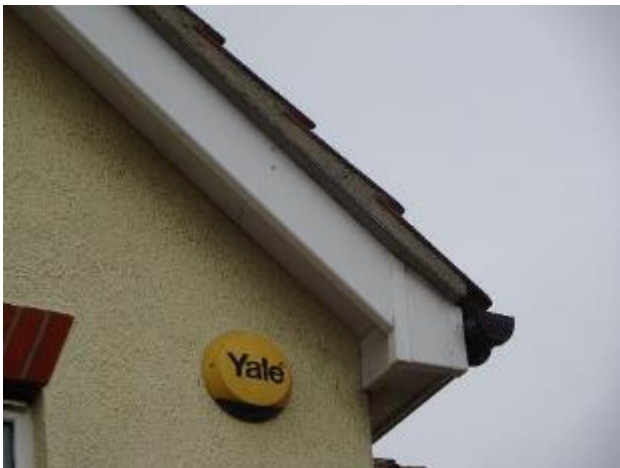
The existing fascia boards to the front gable are finished with uPVC cladding. These should be cleaned on a cyclical basis of every 5 to 6 years but should be next cleaned within the next 12 to 18 months. It was not possible to confirm the condition of the supporting timbers beneath.

19 – uPVC cladding to front gable

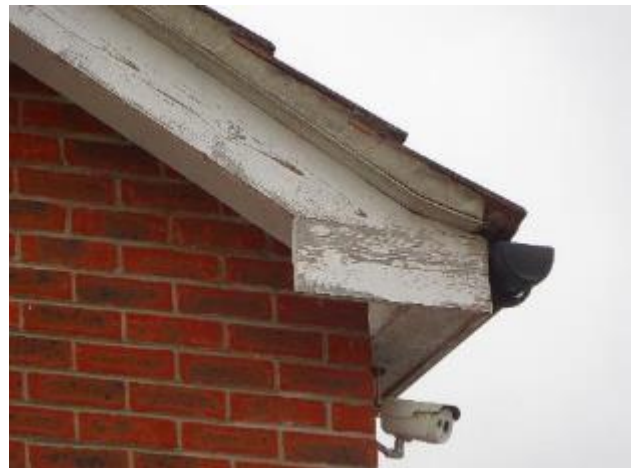
The existing soffits and fascia boards to the remainder of the property are of timber and were found to be in reasonable order, however, it would appear that these have not been decorated for a number of years. These will require general rub down and preparations prior to decoration and it would be recommended that this is undertaken within the next 12 to 18 months to prevent potential damage to the timber then on cyclical basis every 5 to 6 years.

20 – Timber soffit and fascia board

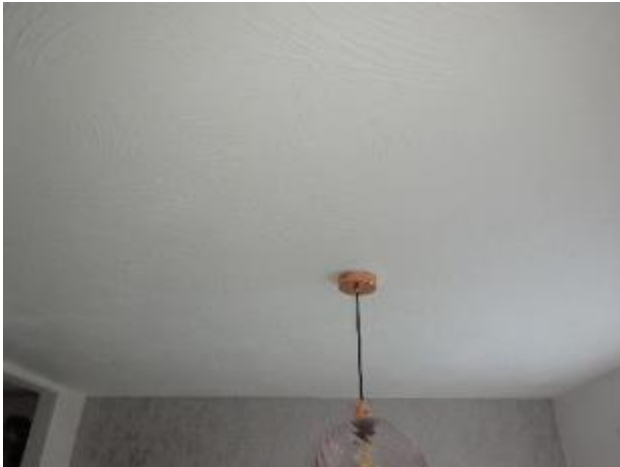
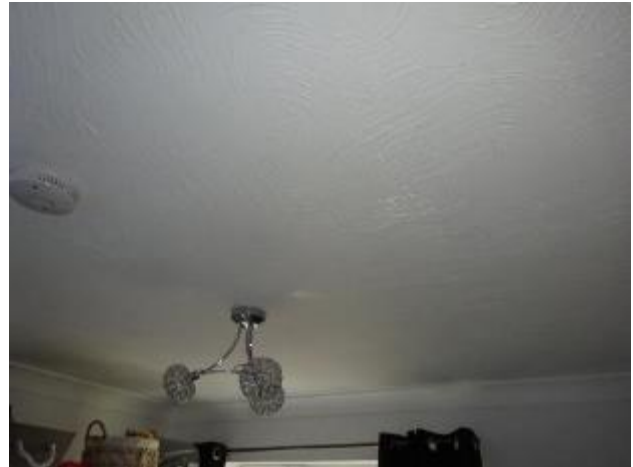
To the ceilings that have been covered with a textured finish can contain low levels of asbestos depending on the age of the material. Asbestos was removed from textured (Artex) coverings in the late 1980's therefore given the age of the property it is unlikely that it would be present here, however, if there are major works being completed it would be recommended that this is tested prior to any removal or major works undertaken to the ceilings.

27 - Textured ceiling to bedroom 1

28 - Textured ceiling to bedroom 2

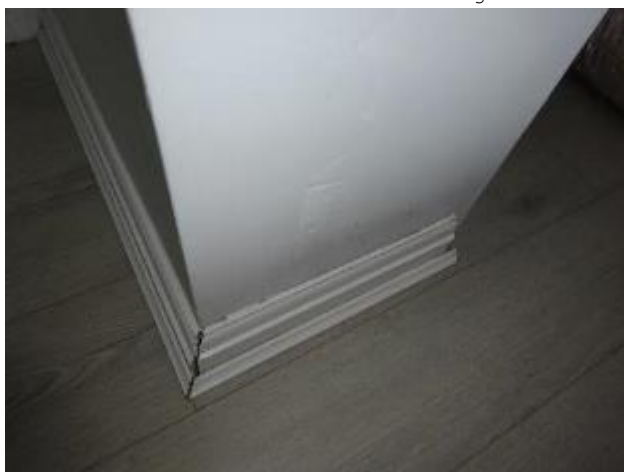
40 – Loose/ unfinished skirting

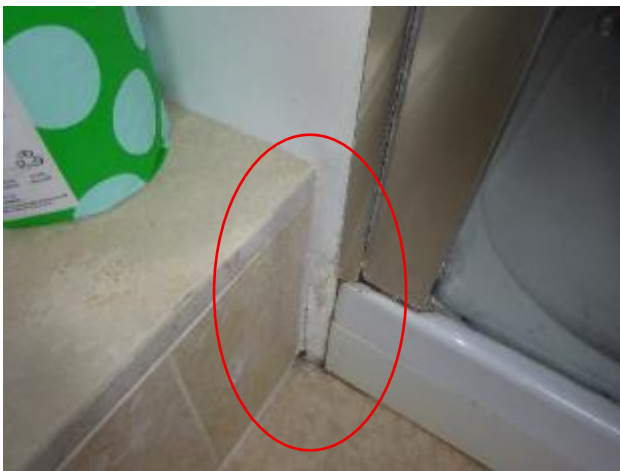
47 - Water damage

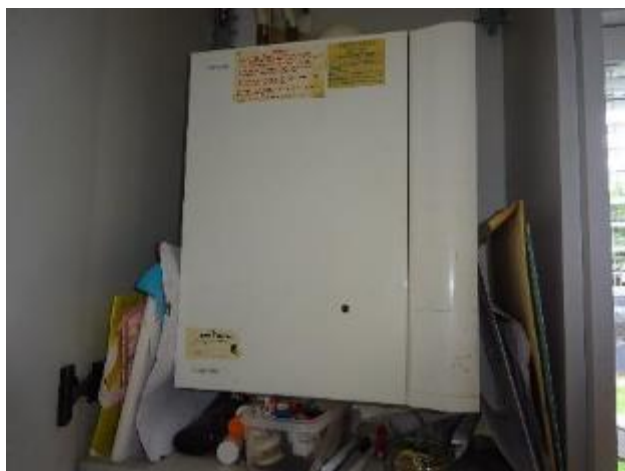
Due to the age of the boiler, it would be deemed to be at the end of its typical life expectancy and as such it would be recommended that the boiler be replaced.

51 – Gas fired boiler

Copies of any recent services should be obtained and if the boiler has not been serviced within the last 12 months, then it is recommended that one is carried out by a qualified engineer.

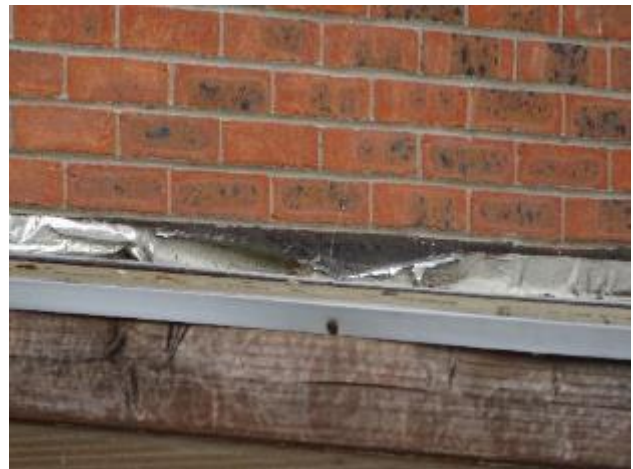
To the side of the property is a timber lean-to structure positioned above the patio to the side. The structure is weathered with polycarbonate roof panels. The flashing between the roof and wall was noted to be in poor order and would benefit from being replaced.

56 - Loose flashing

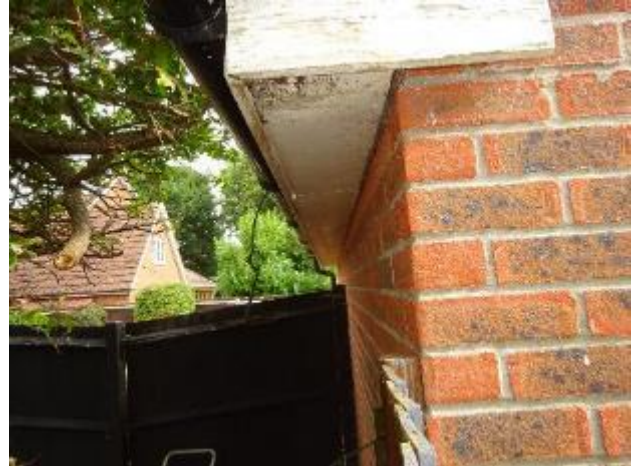
To the rear of the property is a single garage which is of single skin brick construction with brick piers a fair faced brickwork finish with a solid concrete floor, and metal "up and over" doors to the front, and timber door to the side. The garage was generally found to be in good order. The timber joinery to the door, soffits and fascia boards were generally in poor decorative order.

58 - Timber soffits and fascia board
