Homebuyers Survey Report

August 2025

The subject property comprises of semi-detached residential dwelling which briefly comprises of a lounge, kitchen and reception to the ground floor, with three bedrooms and bathroom to the first floor.

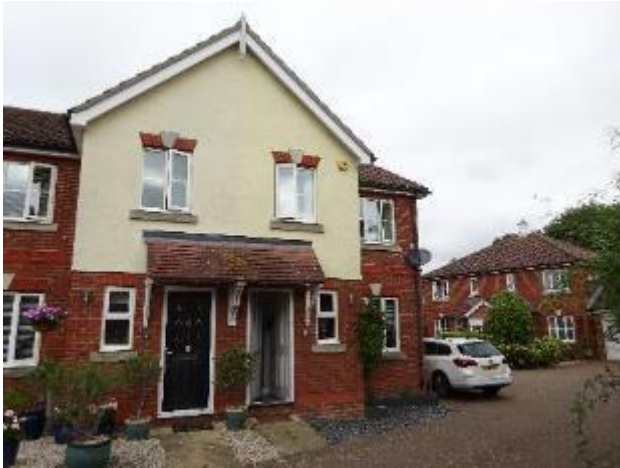
The outside main external walls to the building generally consist of cavity brickwork with all elevations being of fair faced brickwork in a stretcher bond formation. The main walls were noted to be in good order, and no significant distortion or damage was noted to the main elevations.

7 - Front elevation

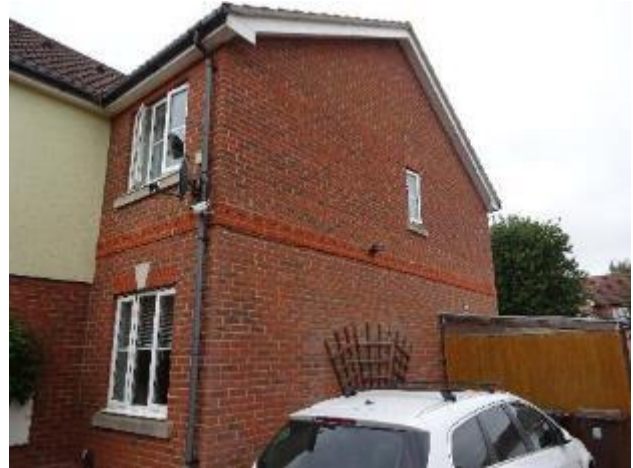
8 - Side elevation

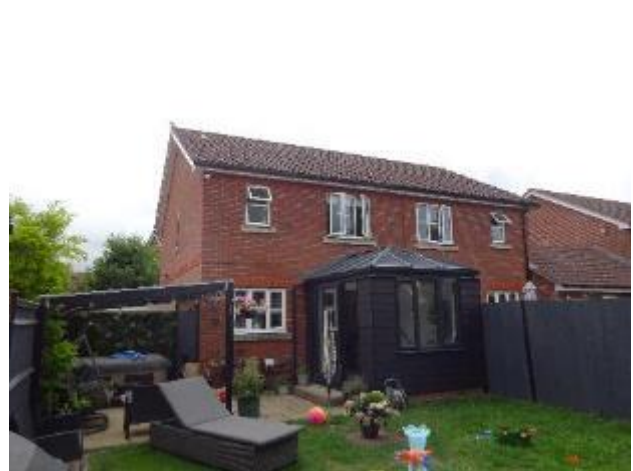
10 - Rear elevation

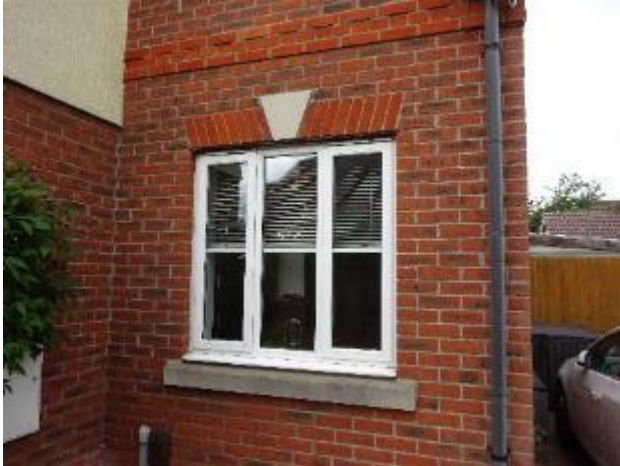
The windows throughout the property are of uPVC construction with uPVC frames and mechanism openings to the various casements. The windows were noted to be in good order, with some debris build-up within the frame making the windows slightly stiff to open. These will require a deep clean with some ease and adjustment in order for them to operate fully.

11 – uPVC window to lounge

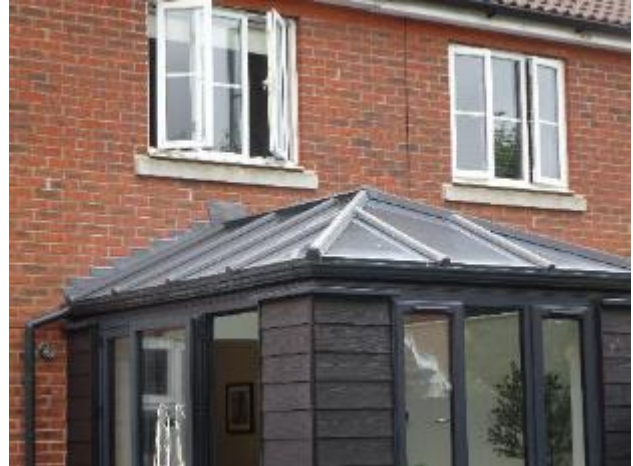
12 – uPVC windows to rear elevation

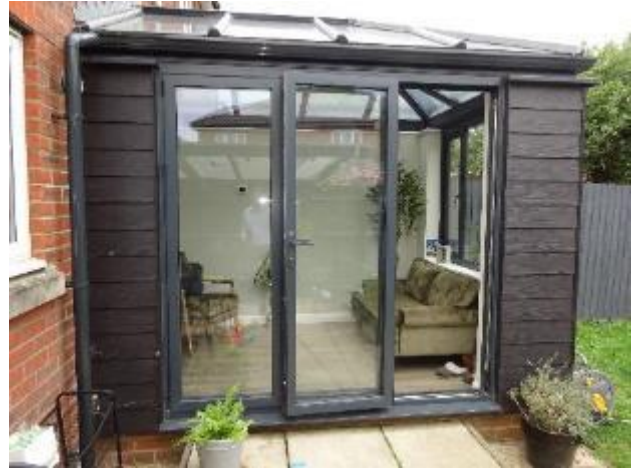
The property is served to the front by a timber door set with glazed panels set in a timber frame. To the rear of the property is an aluminium bi-fold uPVC door set with full-height glazing. The doors were noted to be in good order, it would be recommended to undertake cyclical cleaning of the mechanisms to prevent debris build-up within the frame, ease and adjust hinges and locks.

15 – Bi-fold door to conservatory

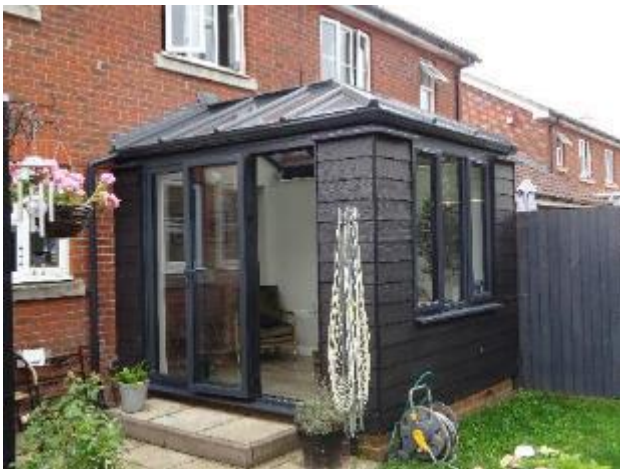
To the rear of the property is a conservatory which comprises of cavity walls with aluminium windows and a hipped roof weathered with double glazed panels and finished with composite cladding panels externally. The structure is understood to have been constructed approximately 12 months ago was noted to be in good order

16 – Conservatory

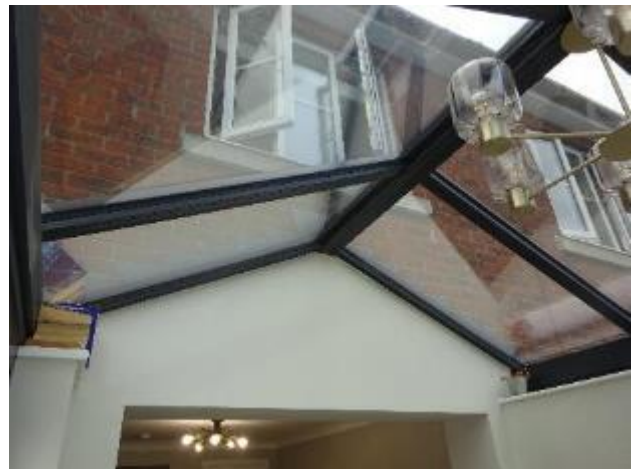
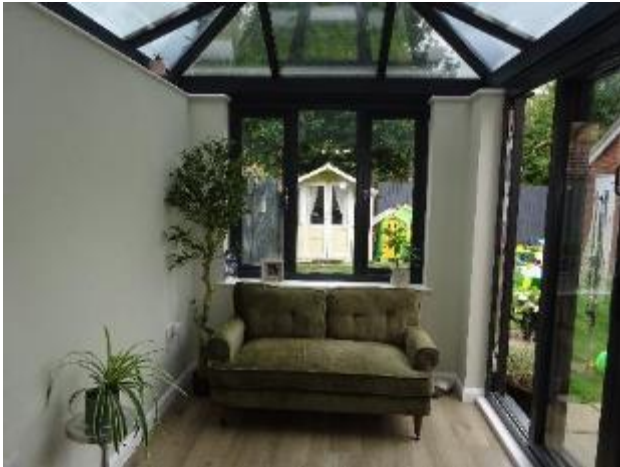
17 – Conservatory internally

18 – Conservatory internally

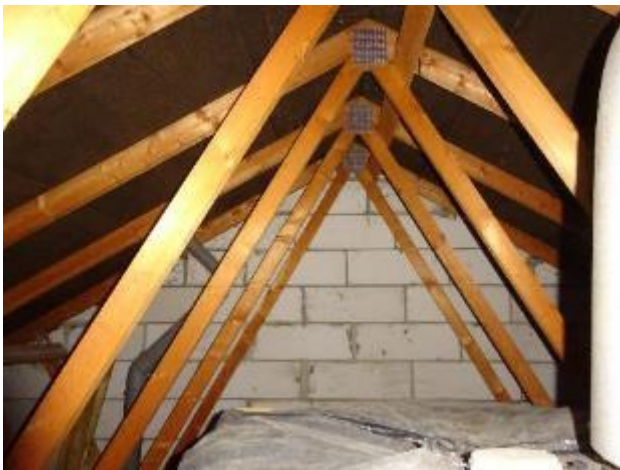
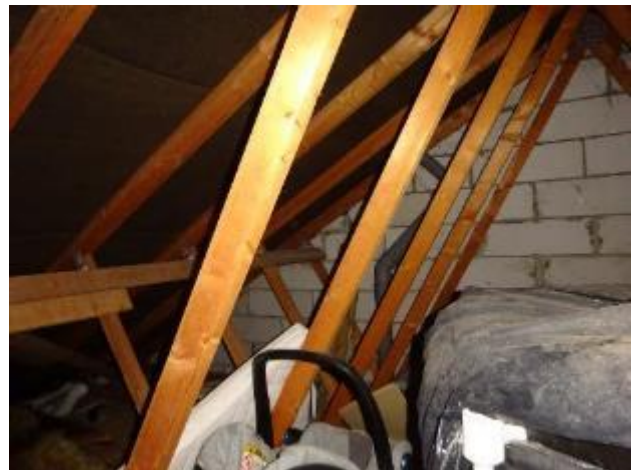
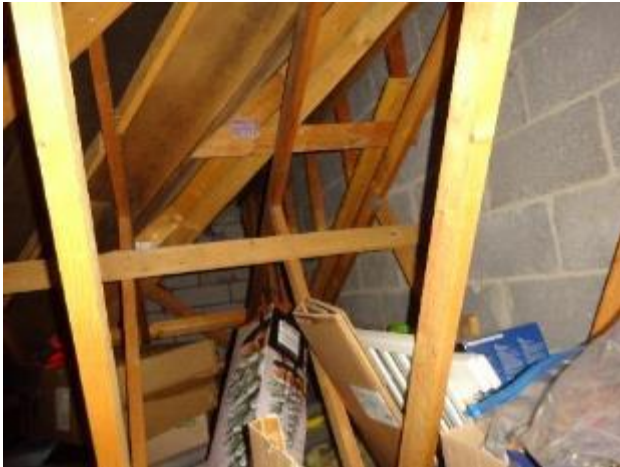
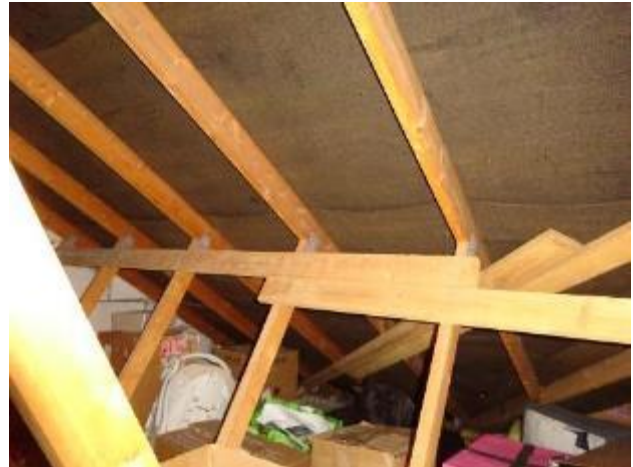
The roof structure is of traditional design and consists of the tiles and battens fixed to the rafters spanning ridge to timber wall plate to the main walls, TRADA trusses spanning front to rear walls. The rafters are retained by timber joists forming the ceiling of plaster below, and with mineral wool insulation between and over the joists. The roof was found to hold good alignment with no significant signs of distortion.

21 – Roof void

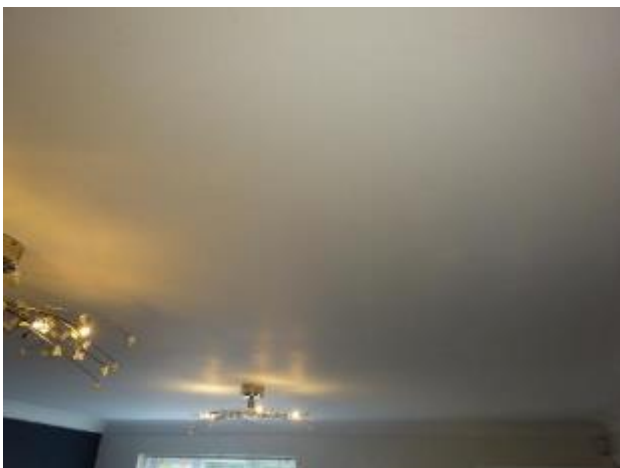
It should also be considered that given the age of the property the smooth plastered ceiling within the lounge may have existing Artex coving behind a plaster skim. Should you consider undertaking major disruptive works to the ceiling then it would be recommended that the ceilings are tested prior to undertaking any major works.

25 – Plaster painted ceiling to lounge

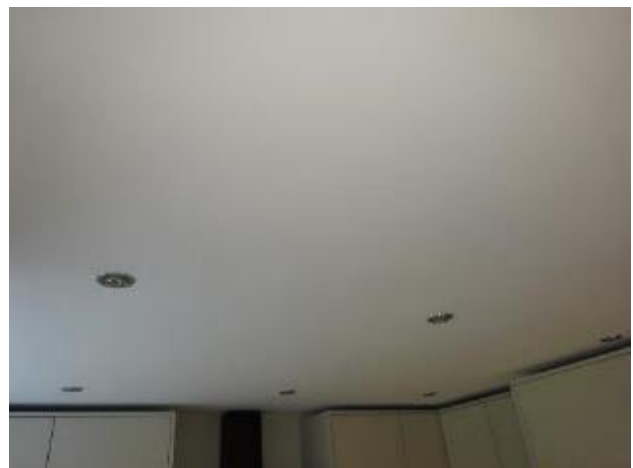
26 – Plaster painted ceiling to kitchen

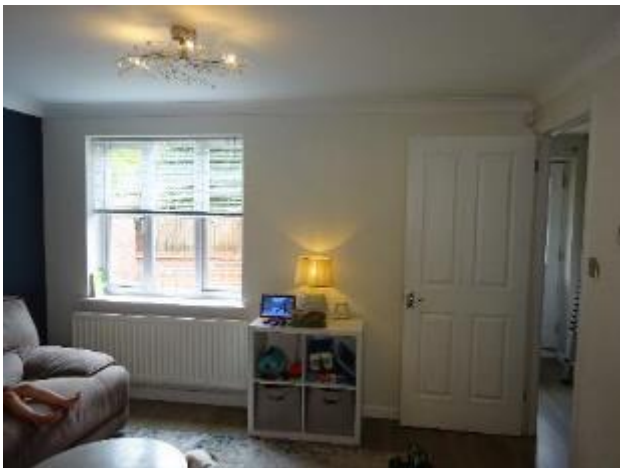
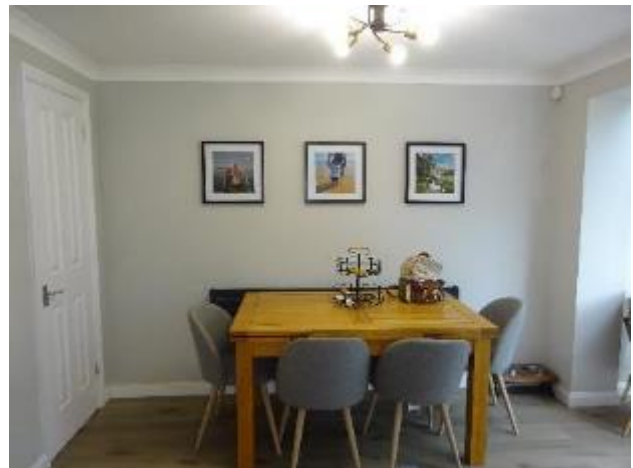
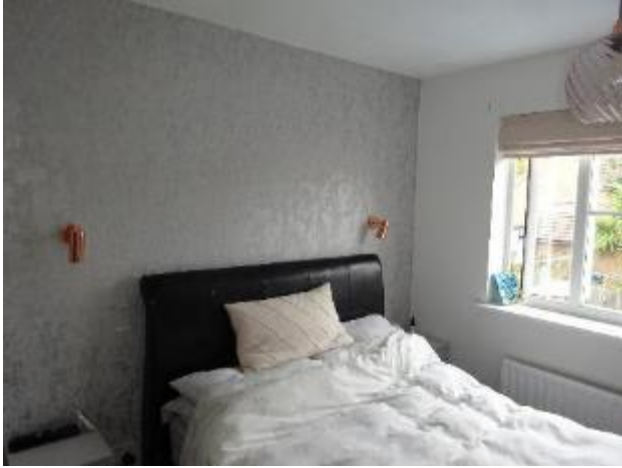
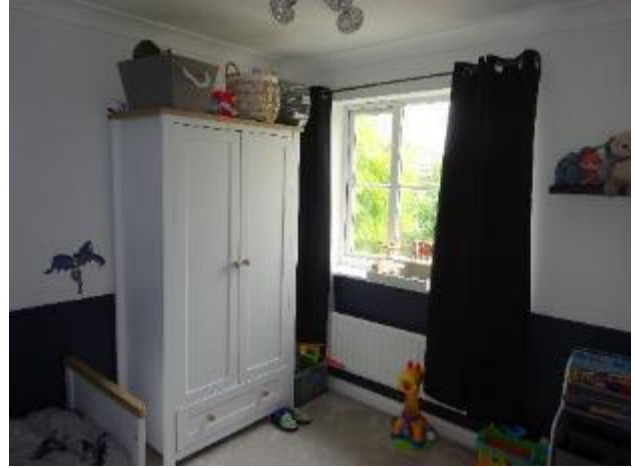
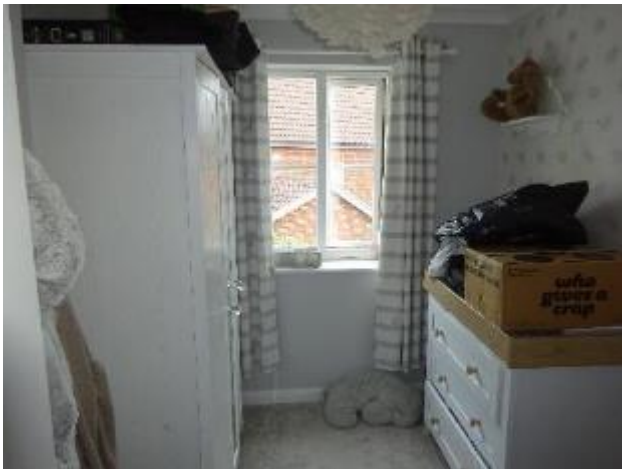
All the internal partitions generally hold good alignment with no evidence of any undue movement or deflection and therefore I must conclude that these remain currently structurally stable. Internally the external walls are finished with various plaster coatings, either painted directly or have a plasterboard lining. The external walls are finished with "dot and dab" plasterboard with a painted finish. The finishes generally remain in good condition with no significant evidence of cracking/ movement.

29 - Lounge

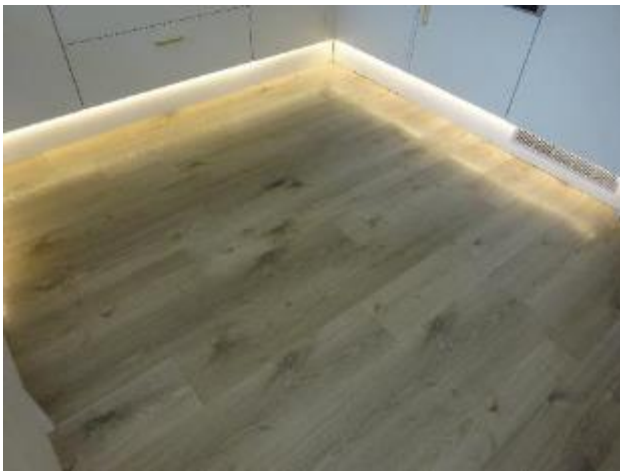
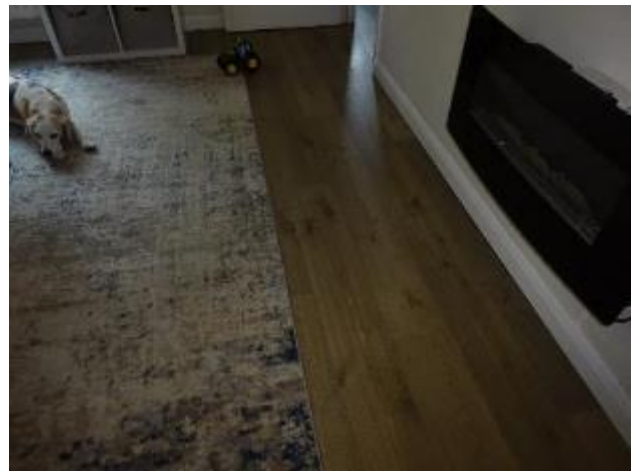
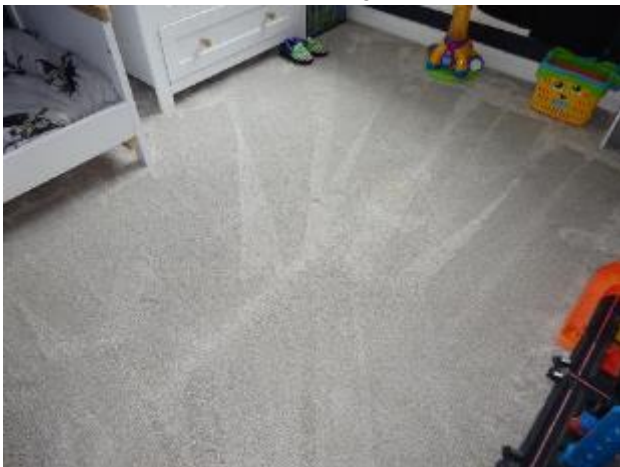
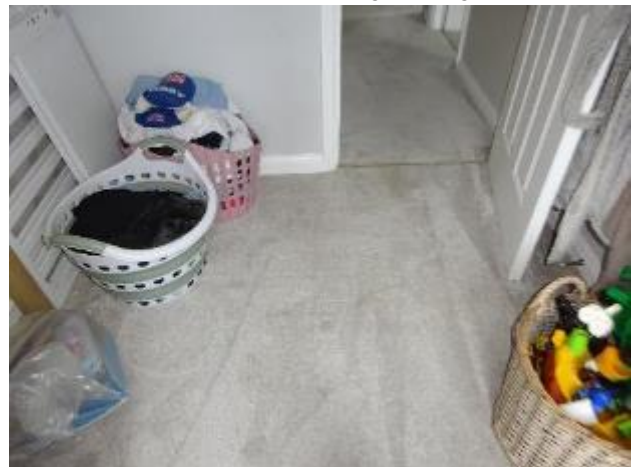
The broadloom carpets and other floor finishes were noted to be in reasonable order, but the carpets may require replacement within the next 4 to 6 years, or during the next cyclical decoration works.

34 - Laminate flooring to kitchen

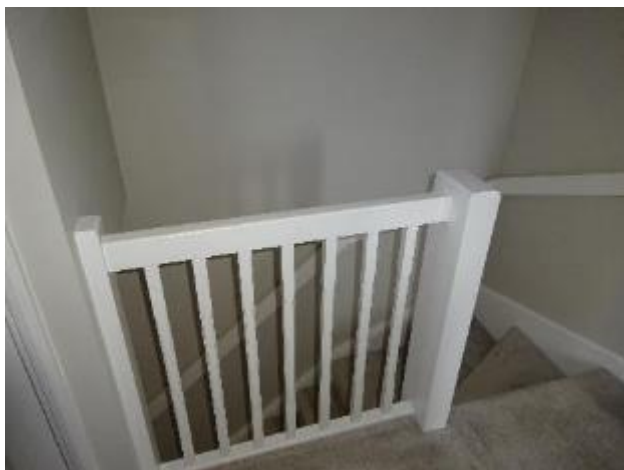
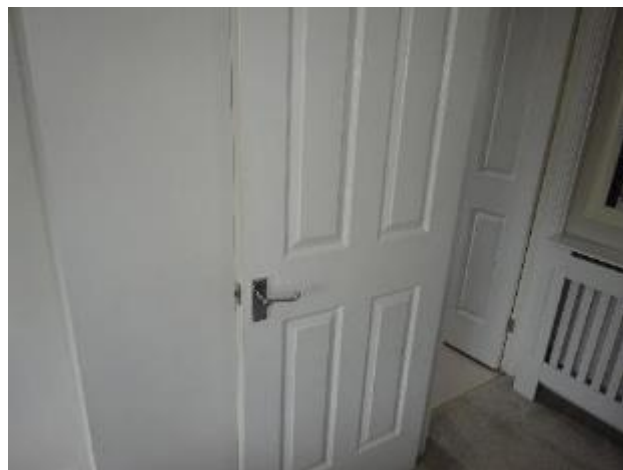
The timber joinery, including skirting boards, doors, door frames and architrave were noted to be in good order and were noted to be decorated to a good quality. It would be recommended to undertake general repairs to some of the door frames and skirting boards and carry out repairs and decorations throughout the property within the next 18 to 24 months and then on a cyclical basis of every 4 to 5 years.

38 – Timber balustrade to landing

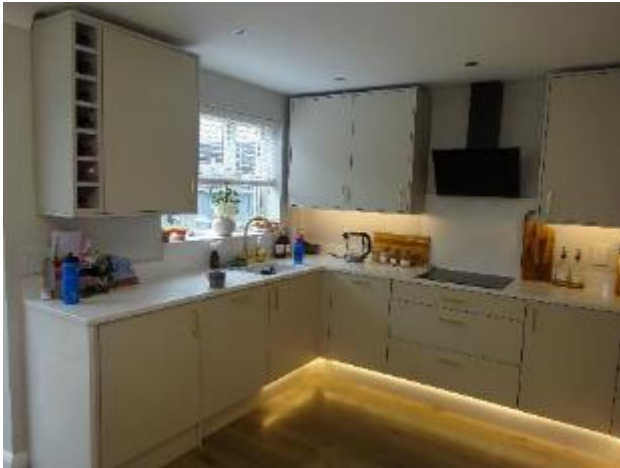
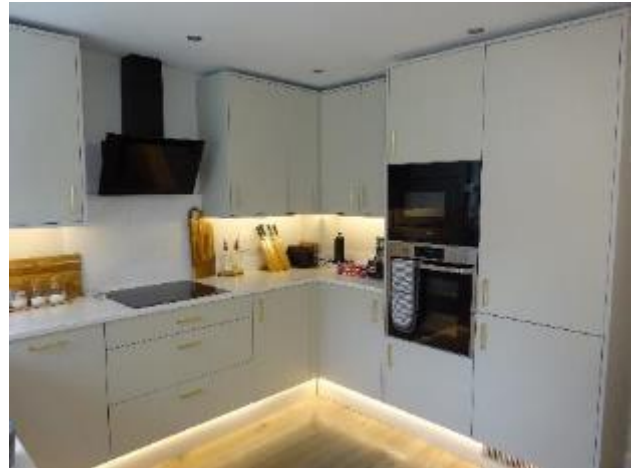
The kitchen within the property comprises of a combination of floor and wall cupboards with a quartz worktop. The kitchen was noted to be in good/ reasonable/ poor condition, and it would appear to have been installed within the last 2 years. It would be recommended for general deep cleaning of all units and surfaces throughout the fixtures and fittings, ease and adjust doors and draws.

41 – Kitchen

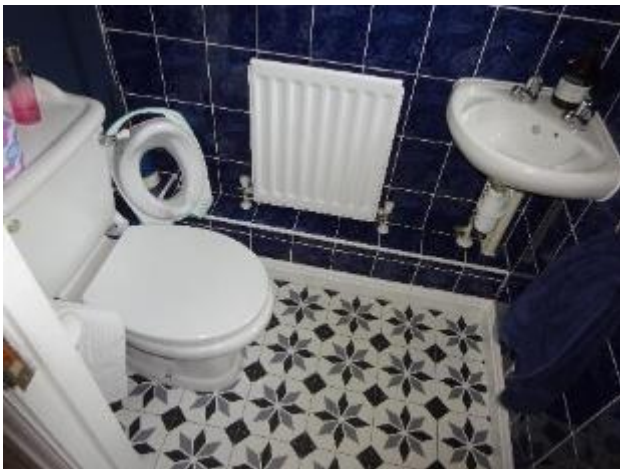
To the ground floor is a WC which comprises of a toilet and wash hand basin. The fixtures were found to be in good order and general deep cleaning of all units and surfaces throughout is recommended.

43 – Ground floor WC

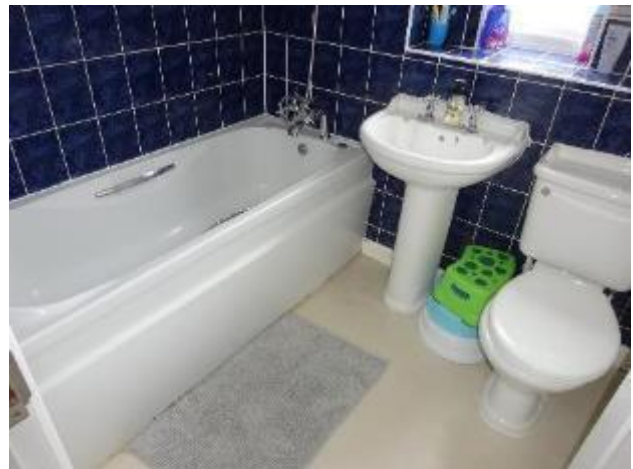
The bathroom within the property comprises of a toilet, wash hand basin and bath. The bathroom was noted to be in reasonable condition, and it would appear to be the original suite from construction. It would be recommended for general deep cleaning of all units and surfaces throughout the fixtures and fittings, however, given the age likely to require replacement within the next few years.

44 – Bathroom

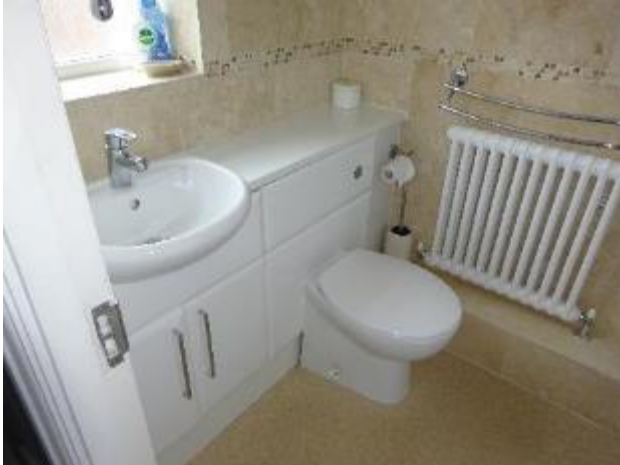
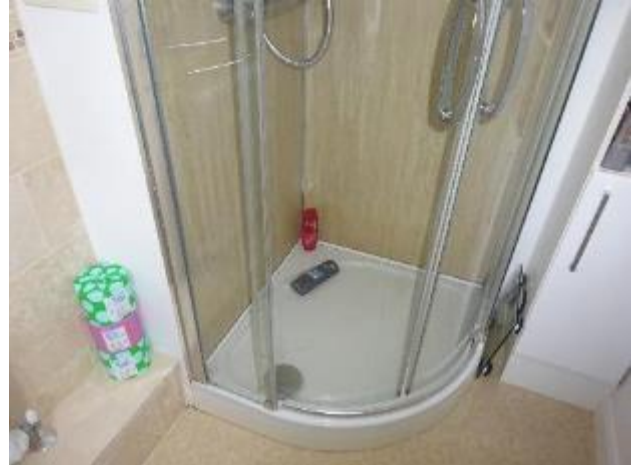
Off of bedroom 1 is an en-suite which consists of a toilet, wash hand basin and shower. The fixtures were found to be in reasonable order and general deep cleaning of all units and surfaces throughout is recommended. Some water damage was noted to the side of the shower, and it would be recommended to renew the silicone sealant around the try and screen of the shower.

45 - En-suite

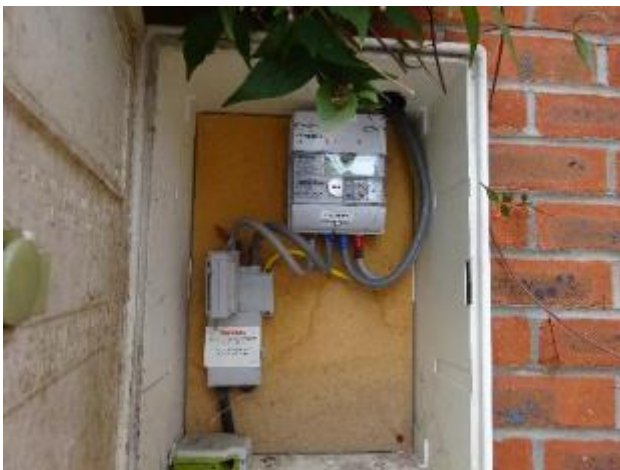
The electrical main enters the property, presumably underground, where it rises to a termination junction leading to the meter positioned within a GRP cupboard at the front of the property and then the fuse board positioned within the ground floor WC. It appears as a single phase 240-volt supply feeding a meter and in turn to a fuse board.

48 – Main incoming electrical supply

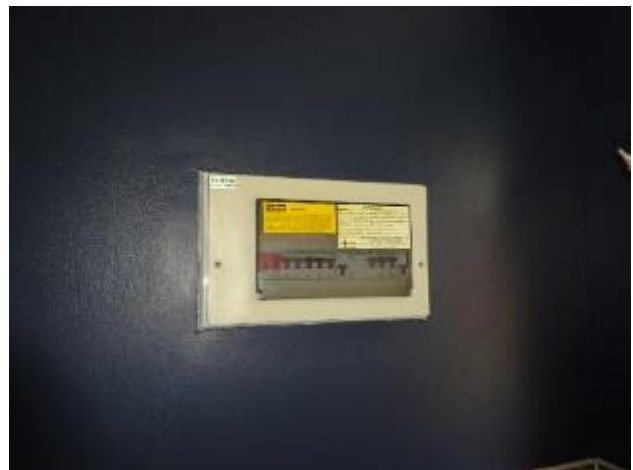
Whilst I cannot fully confirm the serviceability and condition of the electrical installation and considering the age of the ring and lighting installations, the system appears in good order, however, I would still recommend an independent full electrical test by an approved contractor to confirm its serviceability and working order.

49 – Electrical fuse board

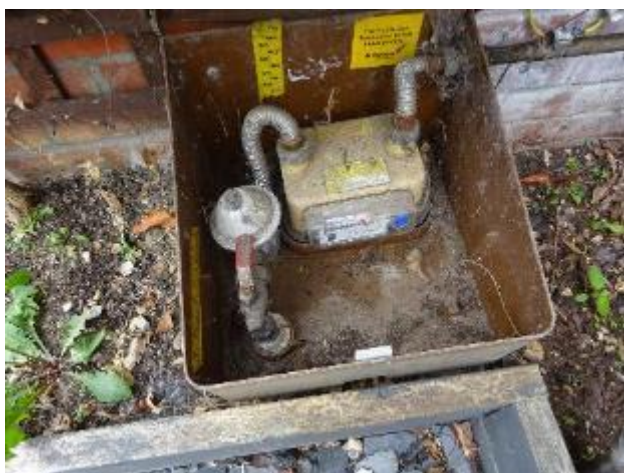
The gas main enters below ground and rises to the meter situated within the GRP box at the front of the property. The installation appeared in good order and copper pipework runs to serve the various gas-fired appliances throughout the property. In many instances, the gas supplied pipework was concealed from view however where this was visible this remained in good order. I have no reason to suspect that the gas supply pipework is in anything other than good and proper condition at this time. As a minimum, I would recommend that the gas fire appliances that are to be retained are serviced by a GasSafe registered engineer to ensure that these remain in safe and proper working order.

50 – Main incoming gas supply

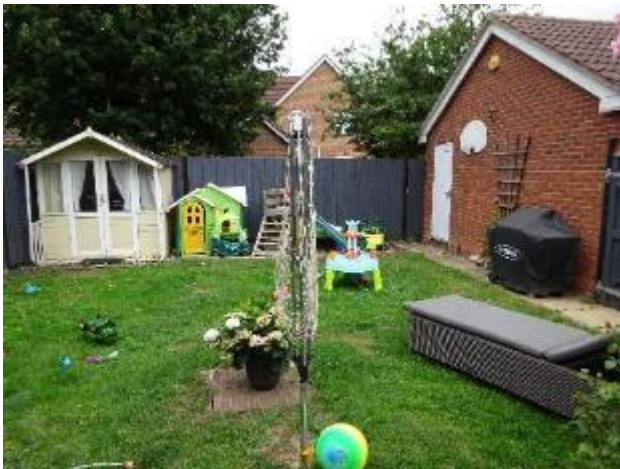
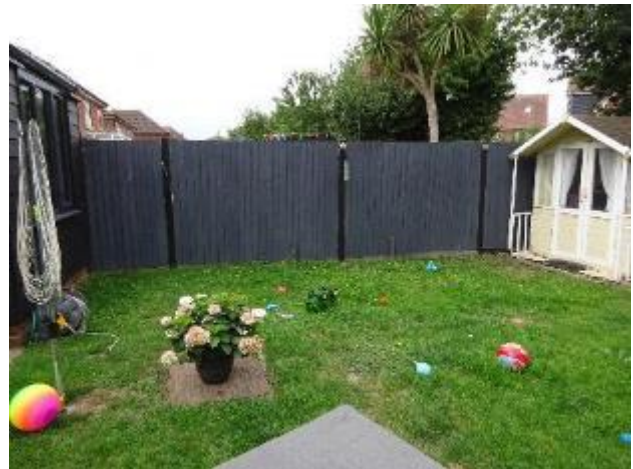
The property has grounds to the rear with access from the conservatory and side access gate. The garden is mainly laid to lawn with an area of concrete paving slabs forming a patio which was noted to be in good order.

The rear garden is bordered with timber fence panels set in timber posts, these were generally found to be in good order. It would be recommended to understand from your legal representative which boundary side you are responsible for.

52 - Rear garden

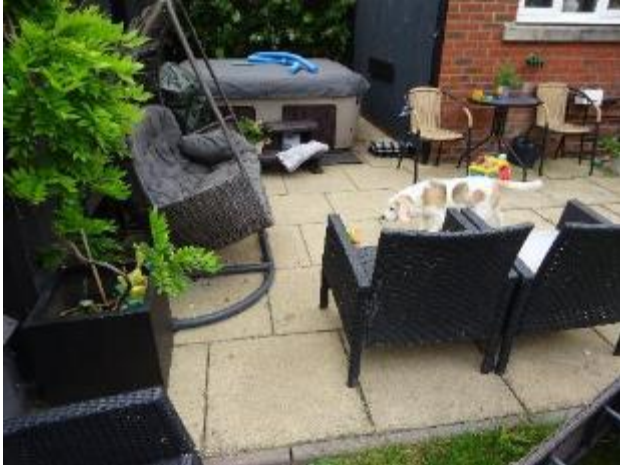
54 - Patio to rear

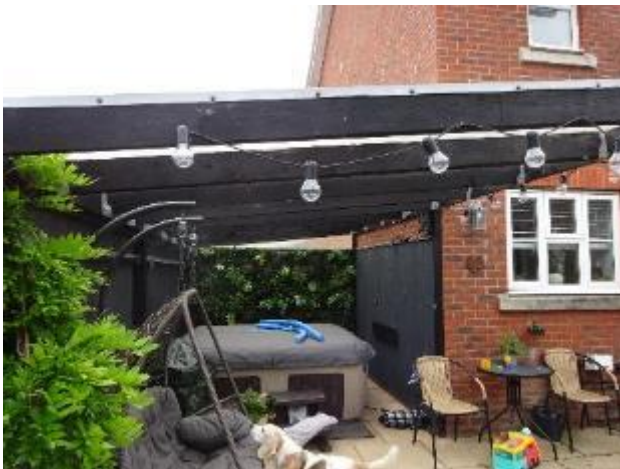
To the side of the property is a timber lean-to structure positioned above the patio to the side. The structure is weathered with polycarbonate roof panels. The flashing between the roof and wall was noted to be in poor order and would benefit from being replaced.

55 - Lean-to structure

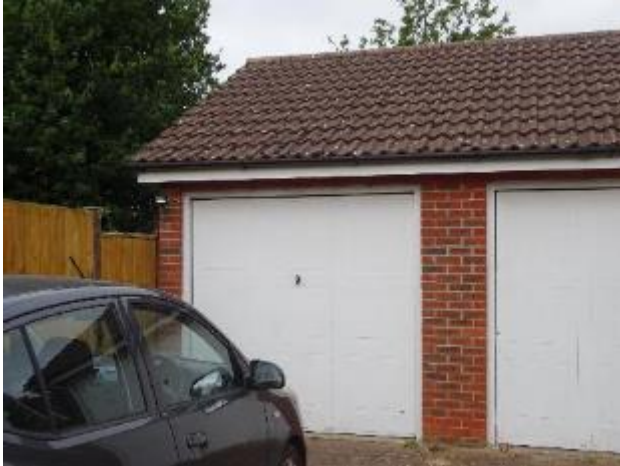
57 - Garage

To the rear of the property is a single garage which is of single skin brick construction with brick piers a fair faced brickwork finish with a solid concrete floor, and metal "up and over" doors to the front, and timber door to the side. The garage was generally found to be in good order. The timber joinery to the door, soffits and fascia boards were generally in poor decorative order.
