# Building Survey Report

[REDACTED] September 2025

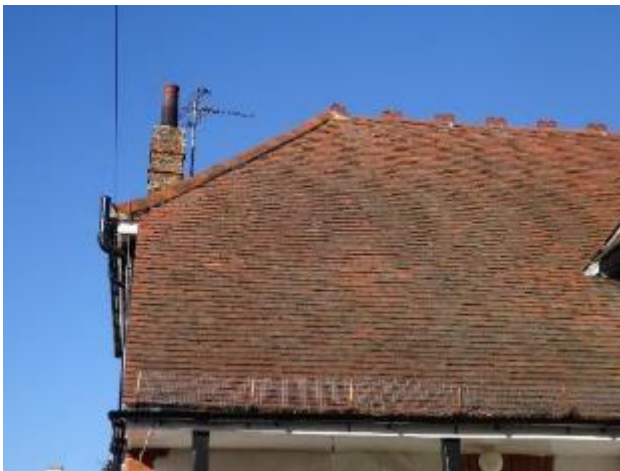
To the elevations moss and lichen growth were noted to the tiles, particularly to the rear along with some damaged, slipped and missing tiles. Over time this can damage and delaminate the tile causing leaks. It is recommended that works to clear the roof tiles is carried out and allow to and undertake bedding repairs to the various ridge tiles identified during those works.

3 – Roof tiles to main roof, front

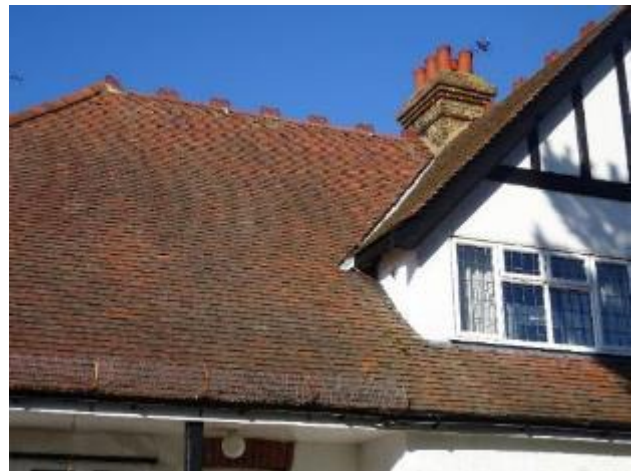
4 – Roof tiles to main roof, front

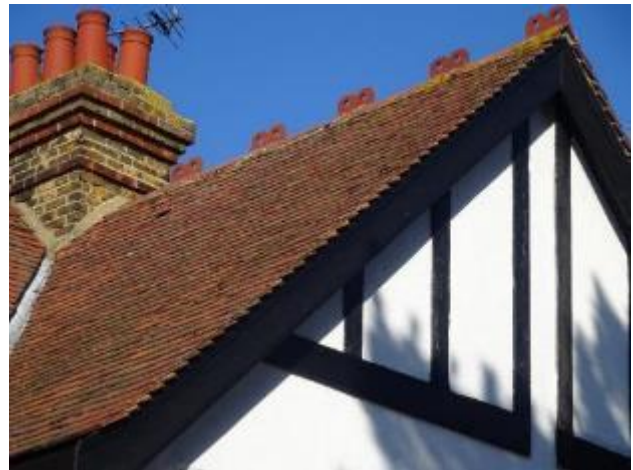
6 – Roof tiles to main roof, front

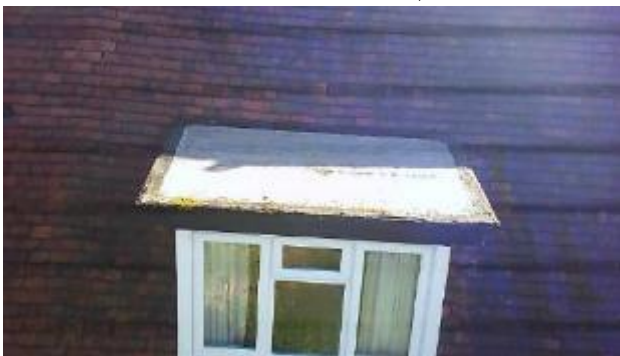
To the rear dormer is a flat roof which is covered with mineral felt covering which was found to be in poor order with some cracks to the felt and slight moss growth. Due to the condition of the flat roof section, it is recommended that this is stripped and replaced.

9 - Flat roof above rear dormer

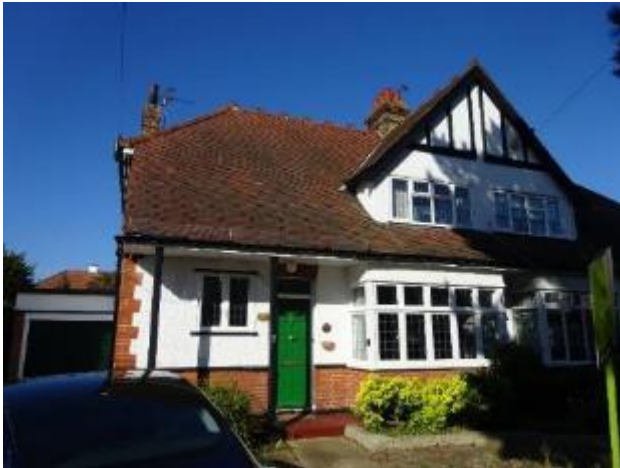
13 – Front elevation

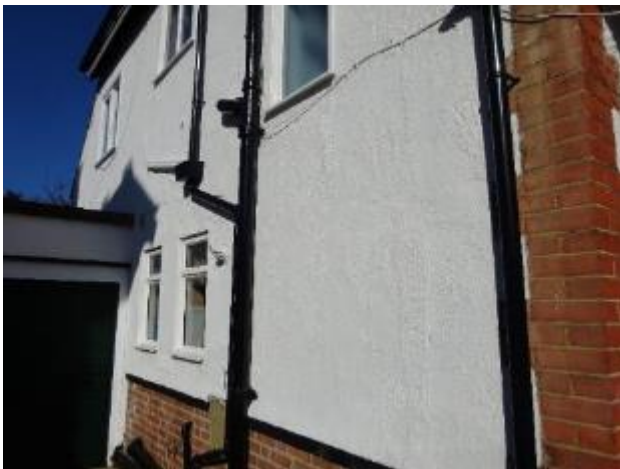
The rendered finish to the property was found to be good order, however, a small number of localised hairline cracking was noted, particularly to the side elevation. It would be recommended that works are carried out to cut out and repair the cracking when undertaking external decorations within the next 12 to 18 months. It is then recommended that the elevations are decorated on a cyclical basis of every 5 to 6 years.

15 – Rendered finish to side elevation

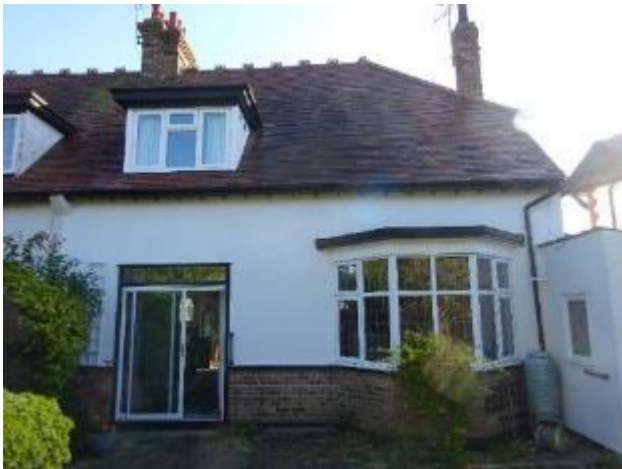
19 - Rear elevation

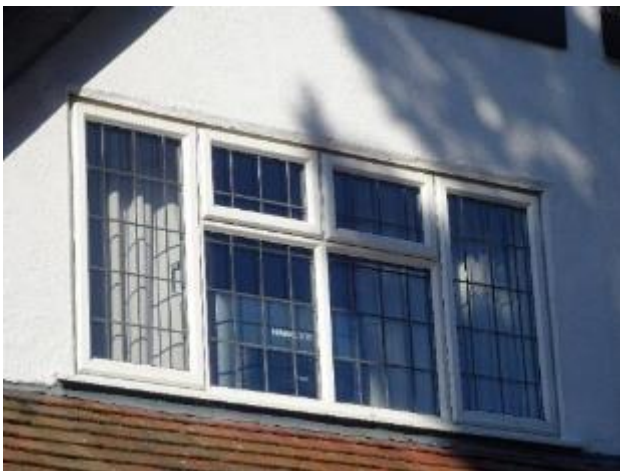
The remaining windows throughout the property are of uPVC construction with uPVC frames and mechanism openings to the various casements. The windows were noted to be in good order, with some debris build-up within the frame making the windows slightly stiff to open. These will require a deep clean with some ease and adjustment in order for them to operate fully.

21 - uPVC window to front bedroom

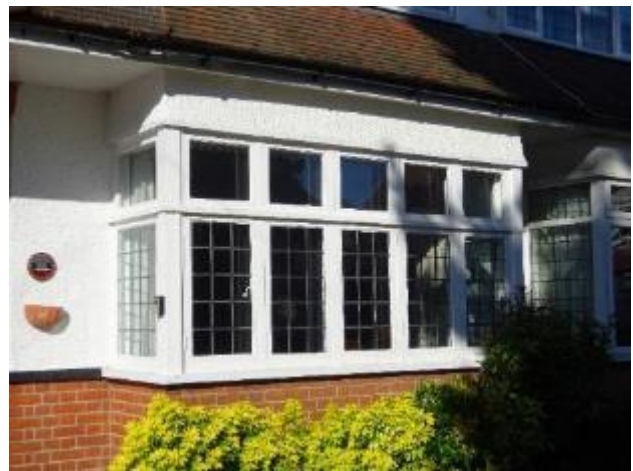
The windows to the ground floor front elevation of the property are of timber construction with single glazed panels with casement and pivot openings to the various frames. The windows were noted to be in reasonable order, and the decorations were found to be flaking and in need of localised repair and decoration, including replacing missing and damaged ironmongery within the next 12 months. It would also be recommended to ease and adjust the individual openings.

22 - Timber casement window to lounge

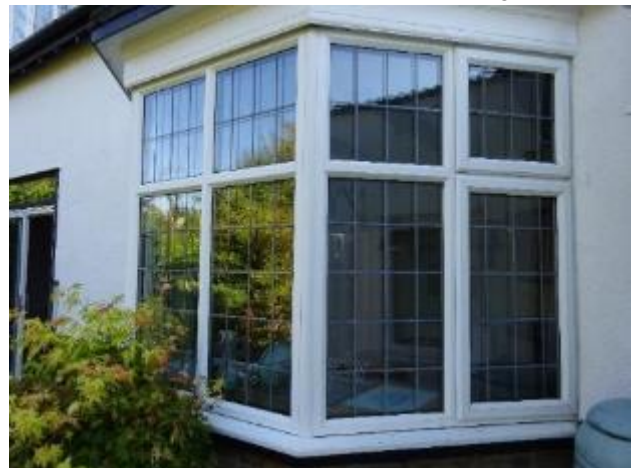
24 - uPVC bay window to kitchen

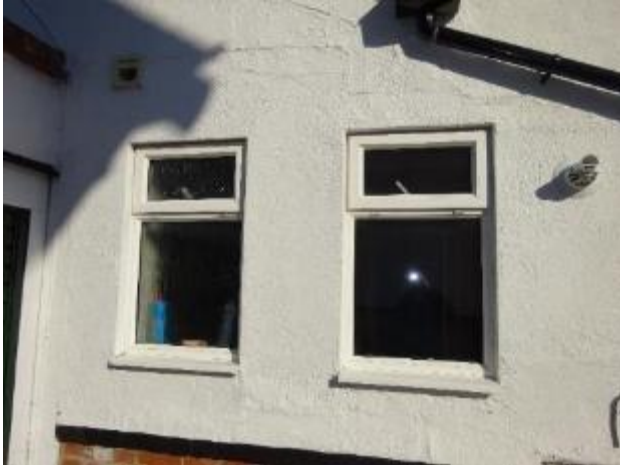
25 - uPVC windows to side elevation

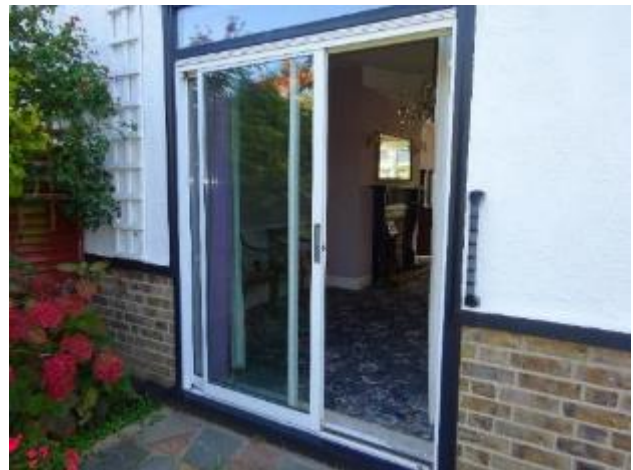
27 - Sliding patio door to rear

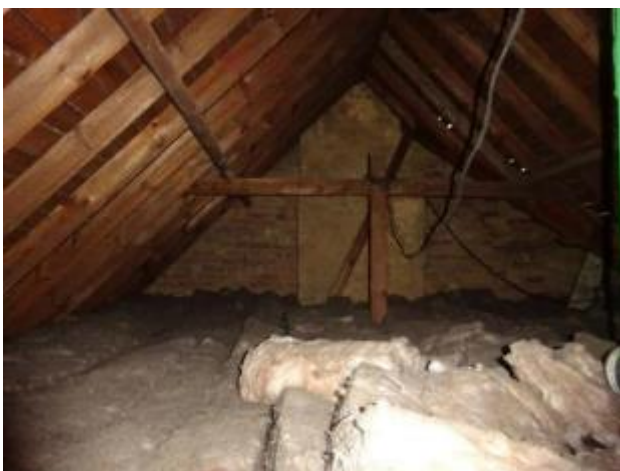
30 – Roof void

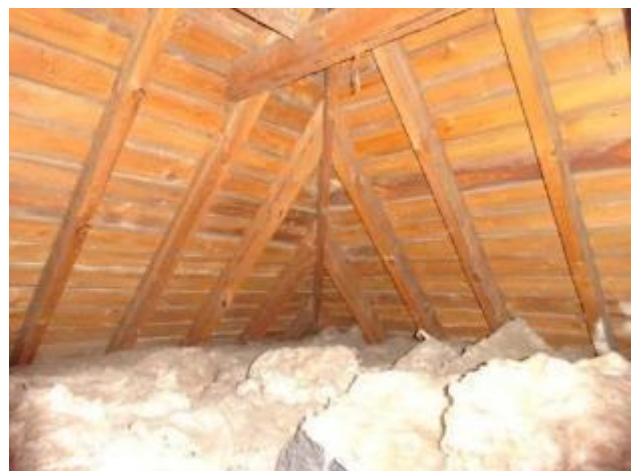
31 – Roof void

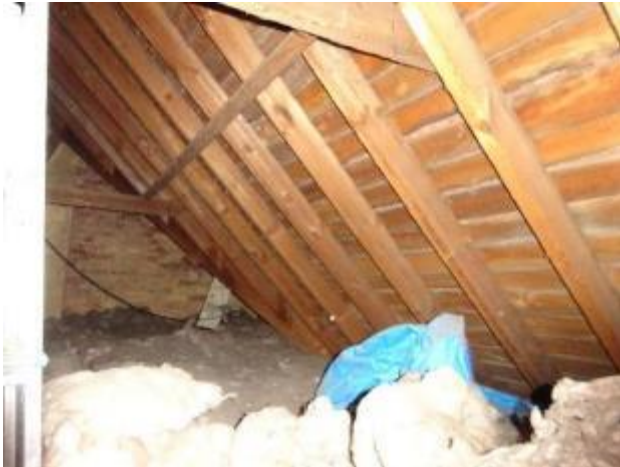
32 - Roof void

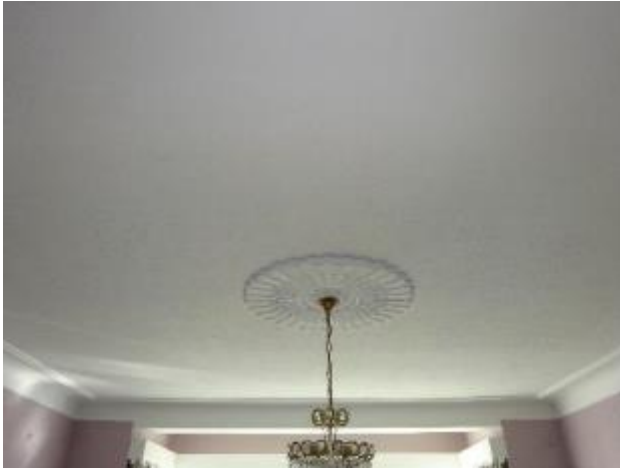
35 - Paper covering to lounge ceiling

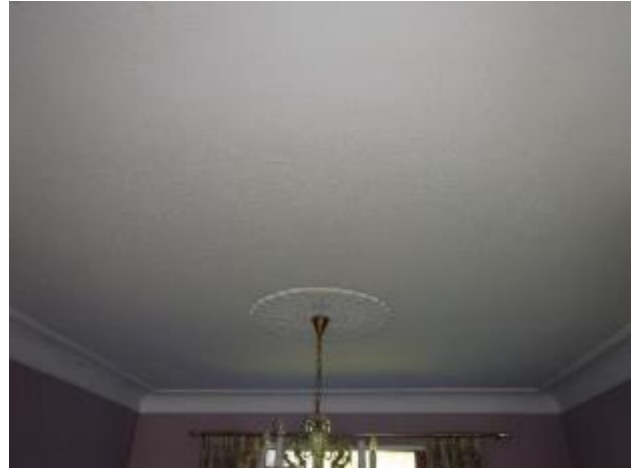
36 - Paper covering to lounge ceiling

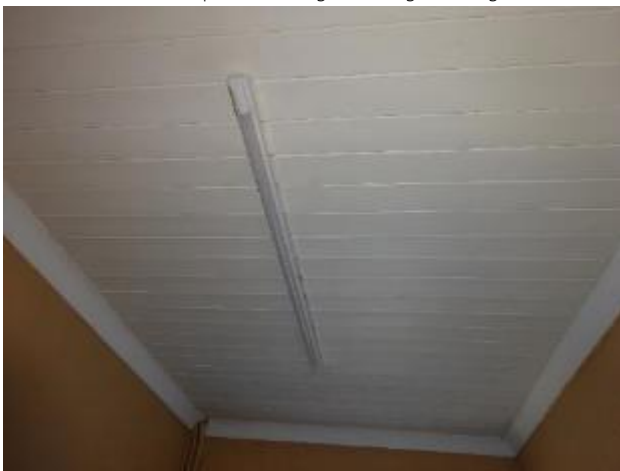
37 - Timber ship lap finish to utility room

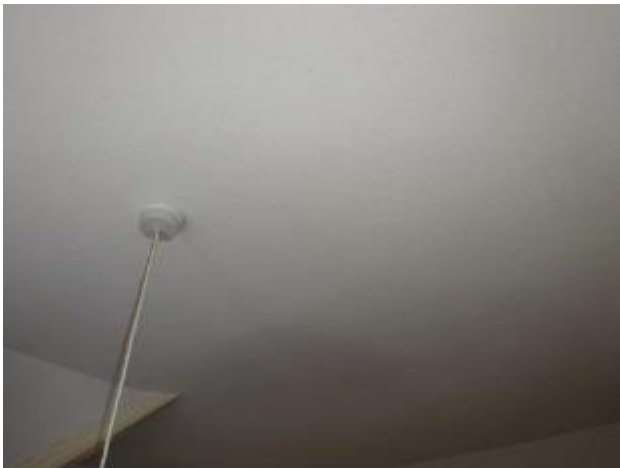
39 - Paper covering to ceiling to bedroom 1

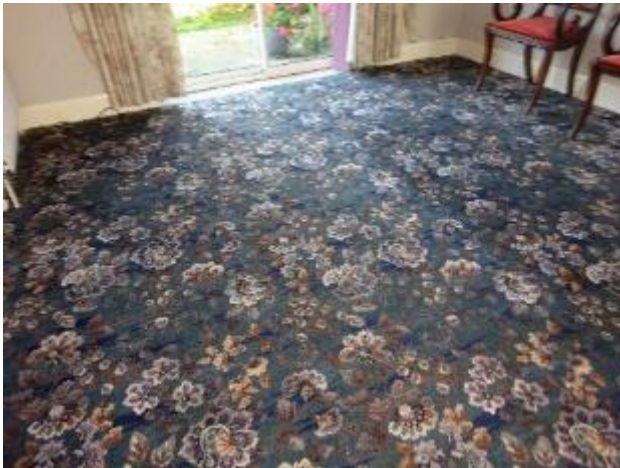
The broadloom carpets and other floor finishes were noted to be in reasonable but dated order, but the carpets may require replacement within the next 6 months, or during the next cyclical decoration works.

43 – Broadloom carpet to lounge

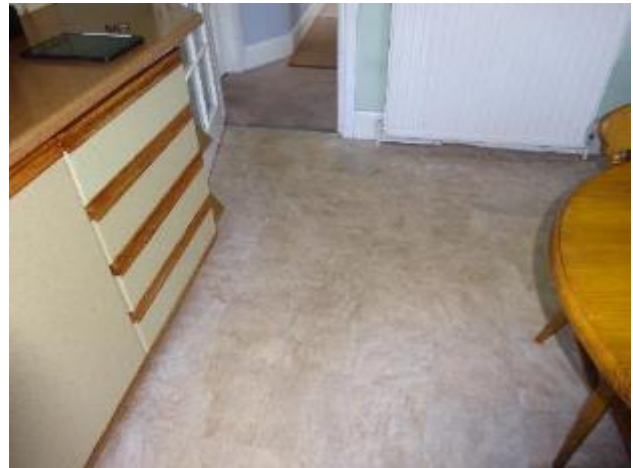
44 – Vinyl flooring to kitchen

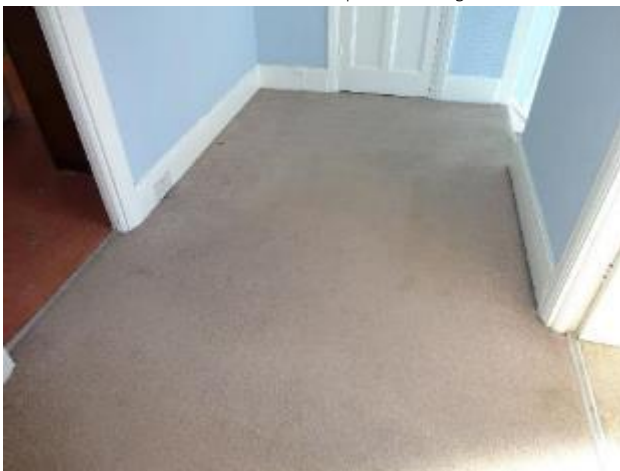
45 – Broadloom carpet to landing

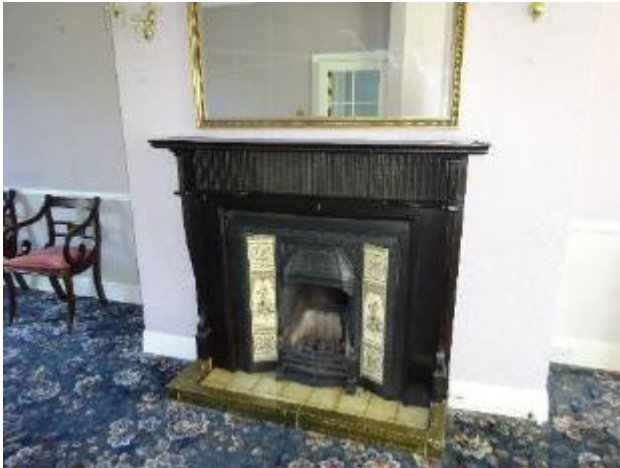
The property has chimney breasts positioned within the lounge and kitchen, and it would be recommended to seek on when the chimney stacks would have been last cleared. The chimney breasts located in the lounge/ dining room/ bedrooms were noted to be blocked over and not vented. It is recommended that vents are installed to prevent moisture buildup within the stack.

46 – Fireplace within the lounge

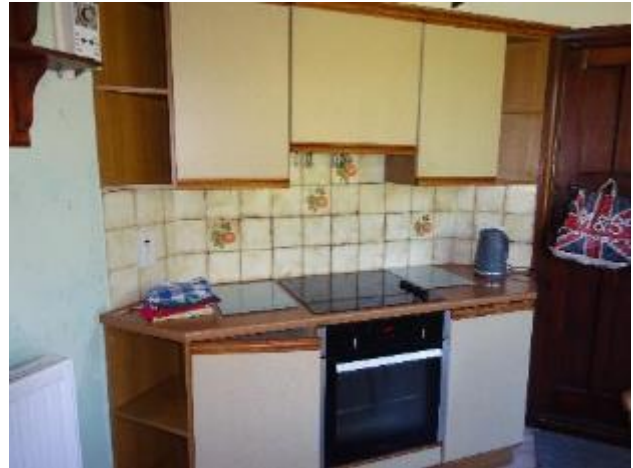
47 – Chimney breast within the kitchen

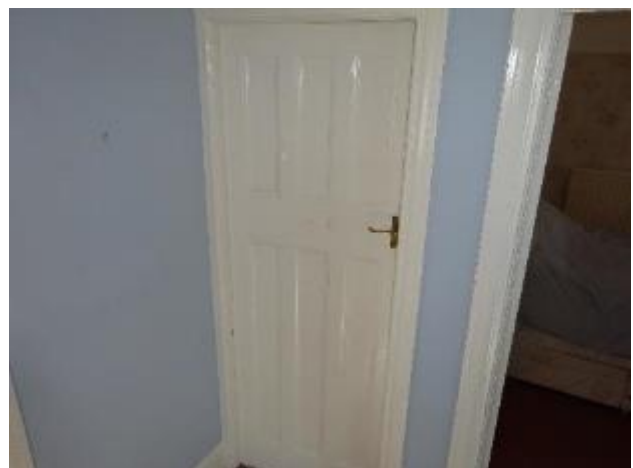
The timber joinery, including skirting boards, doors, door frames and architrave were noted to be in reasonable order and were noted to be decorated to a reasonable quality. It would be recommended to undertake general repairs to some of the door frames and carry out repairs and decorations throughout the property within the next 12 months and then on a cyclical basis of every 4 to 5 years.

49 – Typical internal timber door set

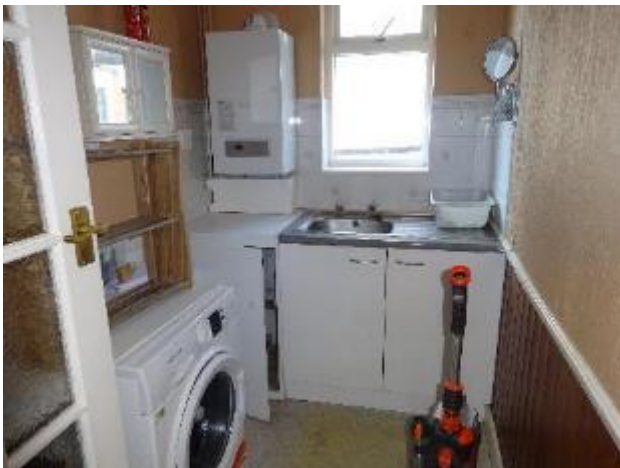
52 - Utility room

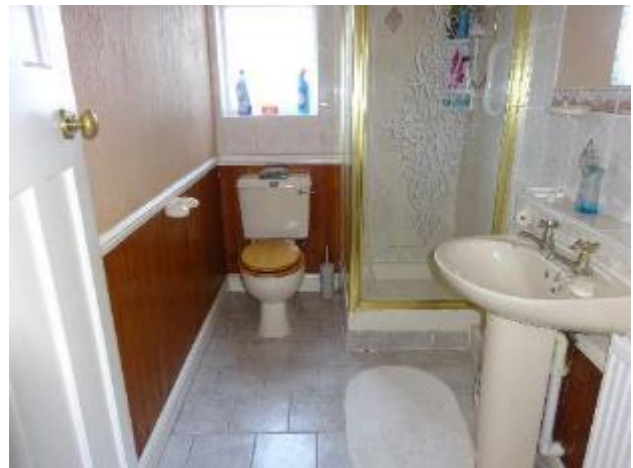
53 - Shower room

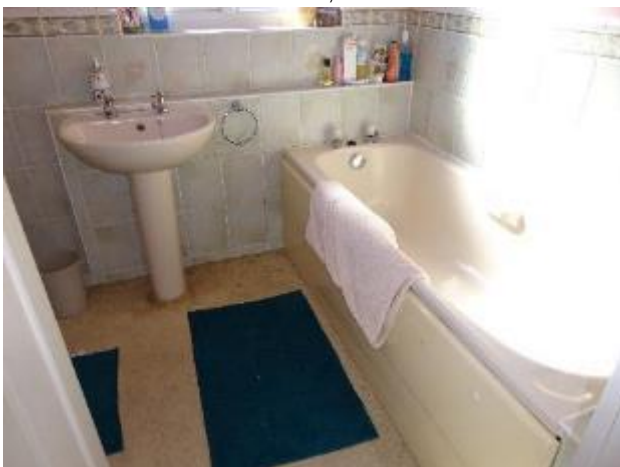
54 - Bathroom

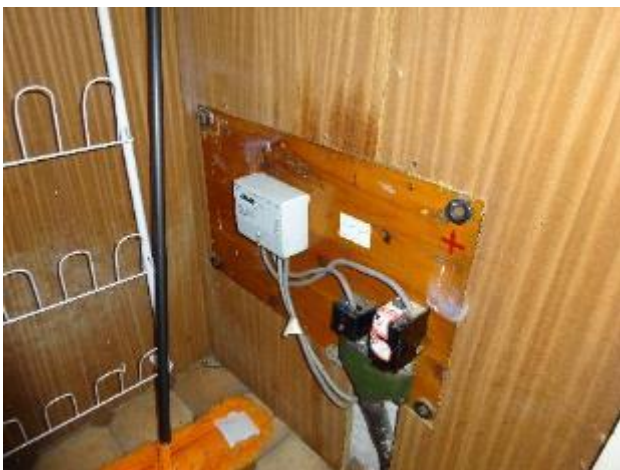
The fuse board is dated along with the wiring, and I would recommend that the property is fully rewired throughout.

56 – Main incoming electrical supply

Whilst I cannot fully confirm the serviceability and condition of the current electrical installation and considering the age of the ring and lighting installations, I would still recommend an independent full electrical test by an approved contractor to confirm its serviceability and working order in the interim.

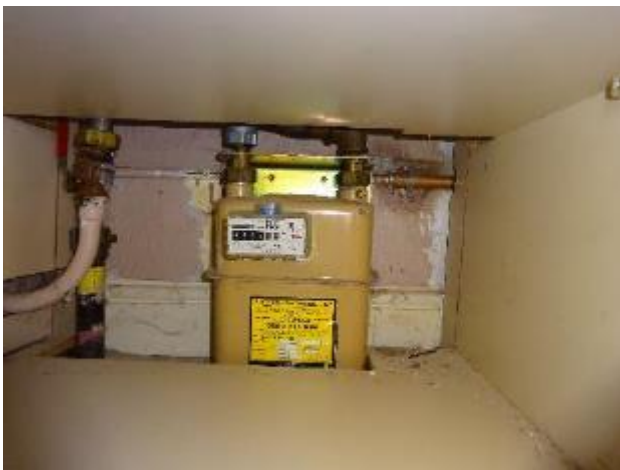
The gas main enters below ground and rises to the meter situated within the utility room cupboard. The installation appeared in good order and copper pipework runs to serve the various gas-fired appliances throughout the property. In many instances, the gas supplied pipework was concealed from view however where this was visible this remained in good order. I have no reason to suspect that the gas supply pipework is in anything other than good and proper condition at this time. As a minimum, I would recommend that the gas fire appliances that are to be retained are serviced by a GasSafe registered engineer to ensure that these remain in safe and proper working order.

58 – Main incoming gas supply

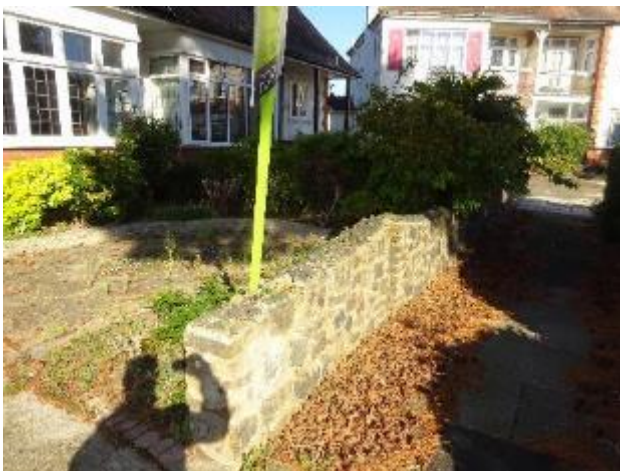
60 – Masonry boundary wall

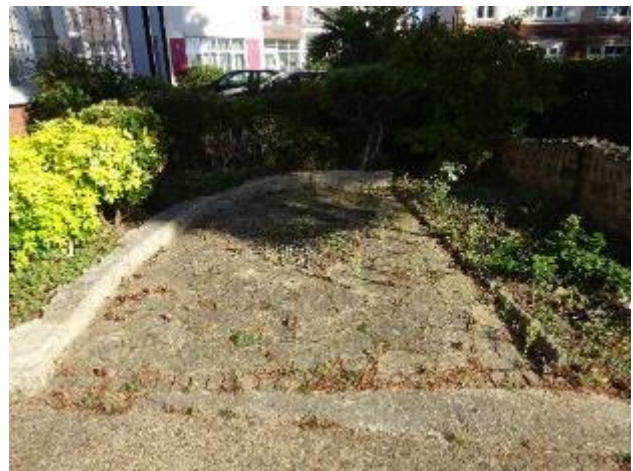
61 – Concrete slabs to front garden

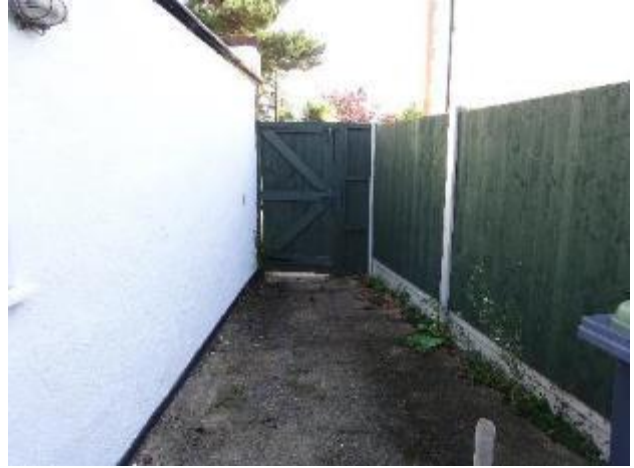
63 – Side access gate

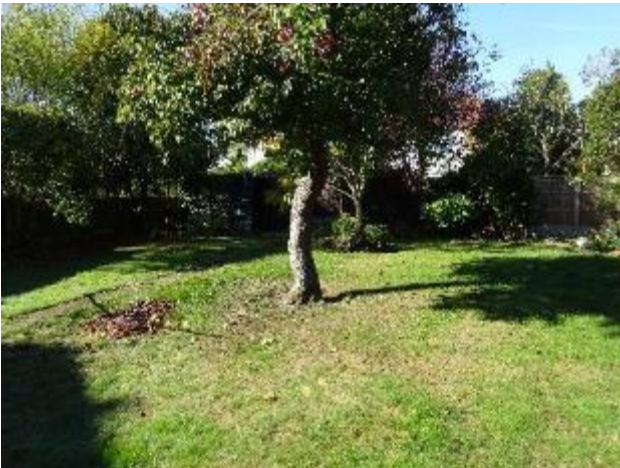
The property has grounds to the rear with access from the lounge and side access gate. The garden is mainly laid to lawn with an area of concrete slabs forming a patio which was noted to have some cracking and unevenness.

66 – Rear garden

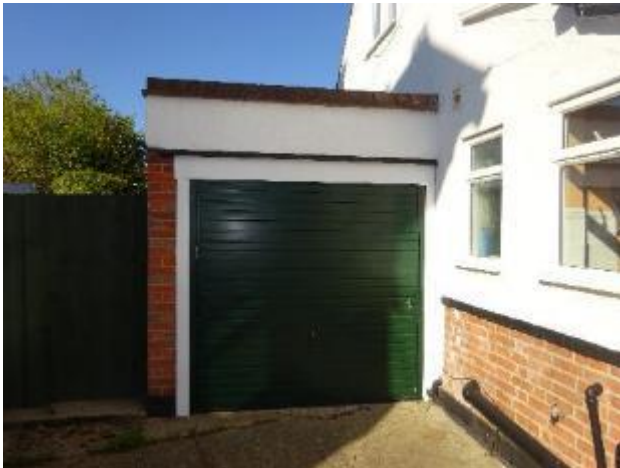
To the side of the property is a lean-to structure forming a garage. The external walls are of single skin brickwork. Settlement movement was noted to the rear junction between the rear wall of the house and garage. Works would be required to tie the walls together in order to prevent further movement.

67 - Garage

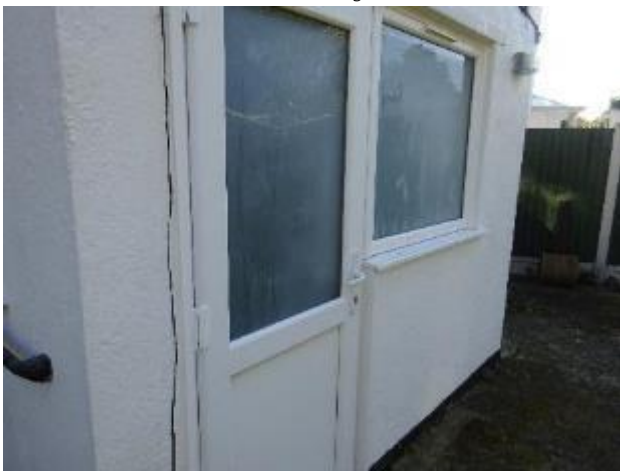
69 - uPVC door to rear

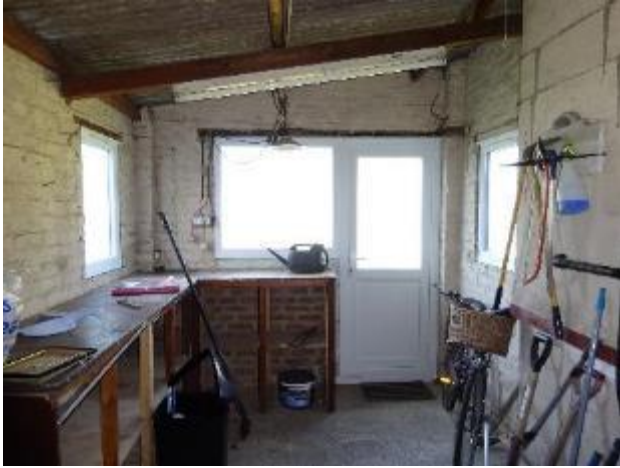
71 - Garage internally
